Final report EMRA

Environmental planning, measures and restoration actions in regulated water systems.

A Swedish-Finnish cross-border-project in the arctic region.

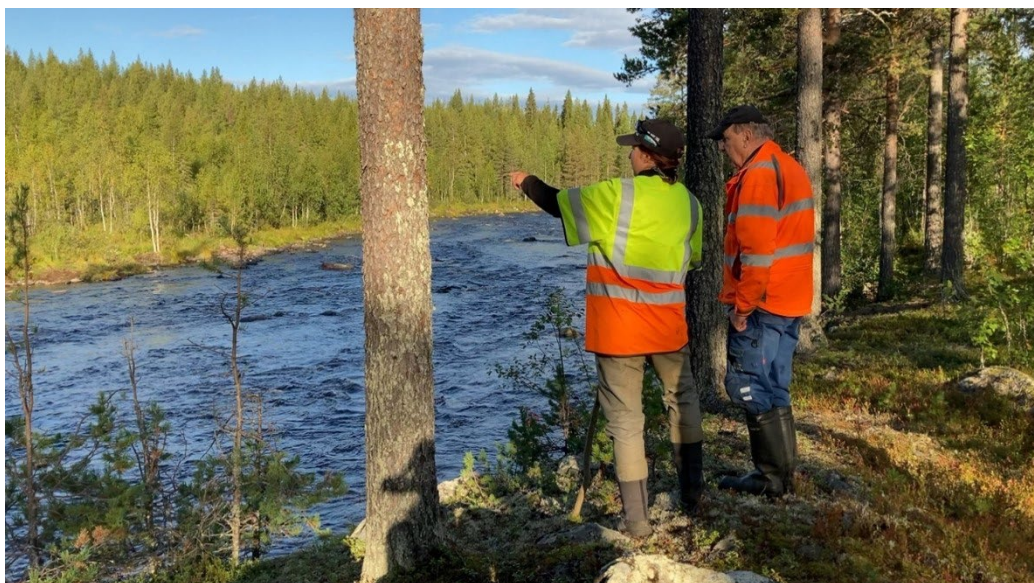
Figure 2. A constructive cooperation between the foreman and the excavator operator is very important. It creates good results and a pleasant working environment. Photo: County Administration Board Norrbotten

The restoration work in Pärälven river is conducted in teams with one foreman and one excavator operator in each team, figure 2. In 2021 there were four excavators (four teams) in Pärälven river and in 2022 there were three excavators (three teams). All teams are supervised by a coordinator. The coordinator is an aquatic ecologist with experience of restoration measures from previous projects (e.g., the LIFE project ReBorN). The coordinator has an overall responsibility of the measures.

The most common way of restoring a river stretch, is to start upstream and work downstream along with the current. The excavator extends its arm out from the water, almost into the forest, to reach all the material that belongs to the riverbed. It clasps the rocks and positions it wherever the foreman decides. Before any excavator starts digging, the foremen together with the coordinator, plan, and design how the restoration work will take place. Together they create a goal of what the stream section will look like and what structures it shall have when the restoration work is completed.

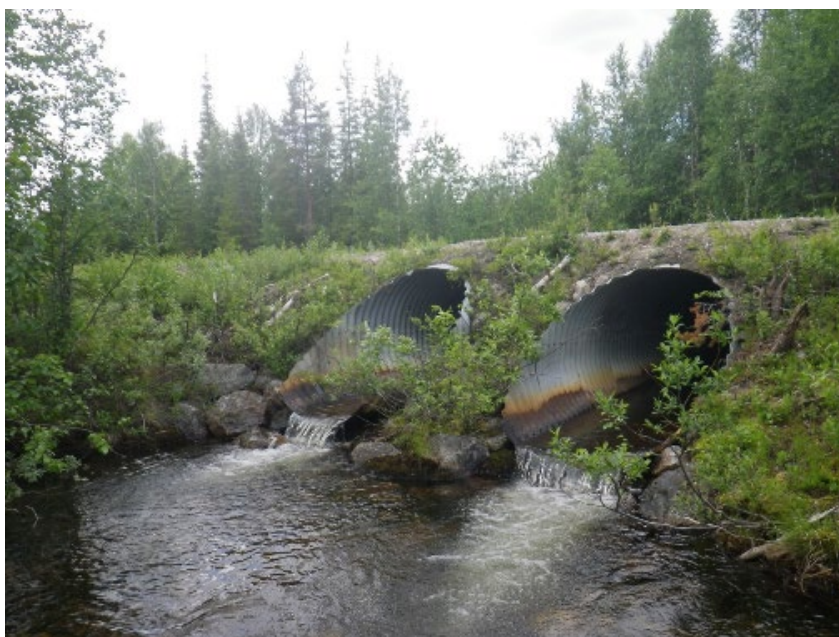
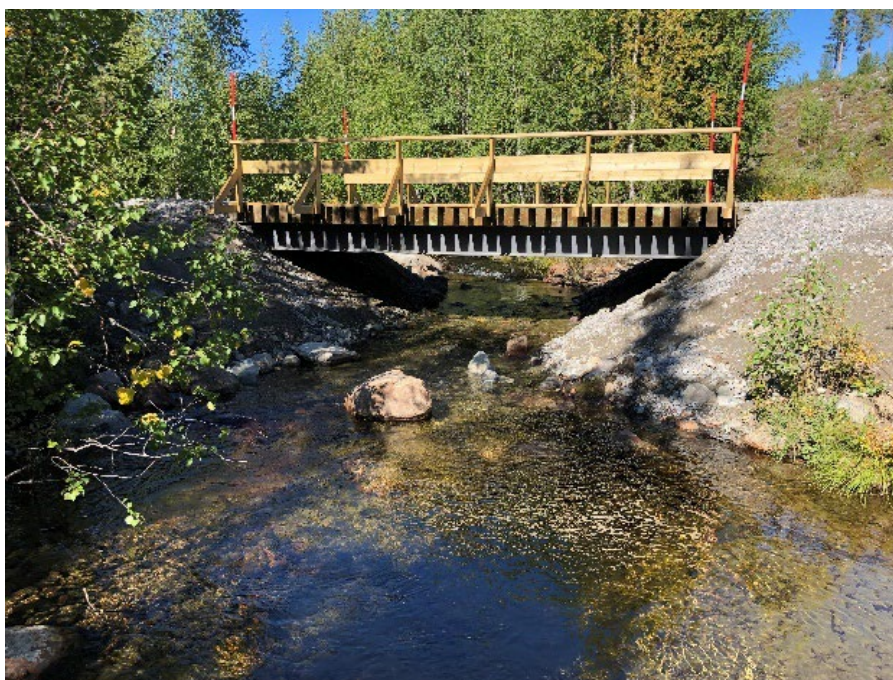
Figure 10. The photos are taken before and after remediation of migration barrier, object 1. Two culverts which both created a drop at the outlet. The culverts were also lacking bottom substrate. The long culverts have been replaced with a bridge so that the water stream can regain its original width and now also have bottom substrate mixed with bigger stones. Photo: County Administration Board.

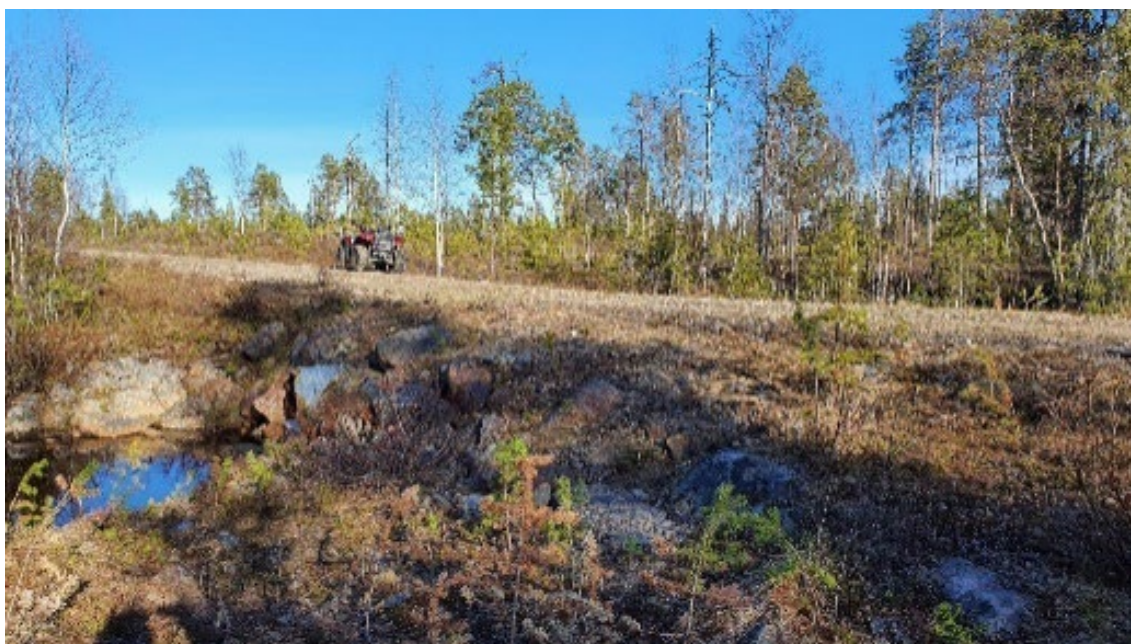
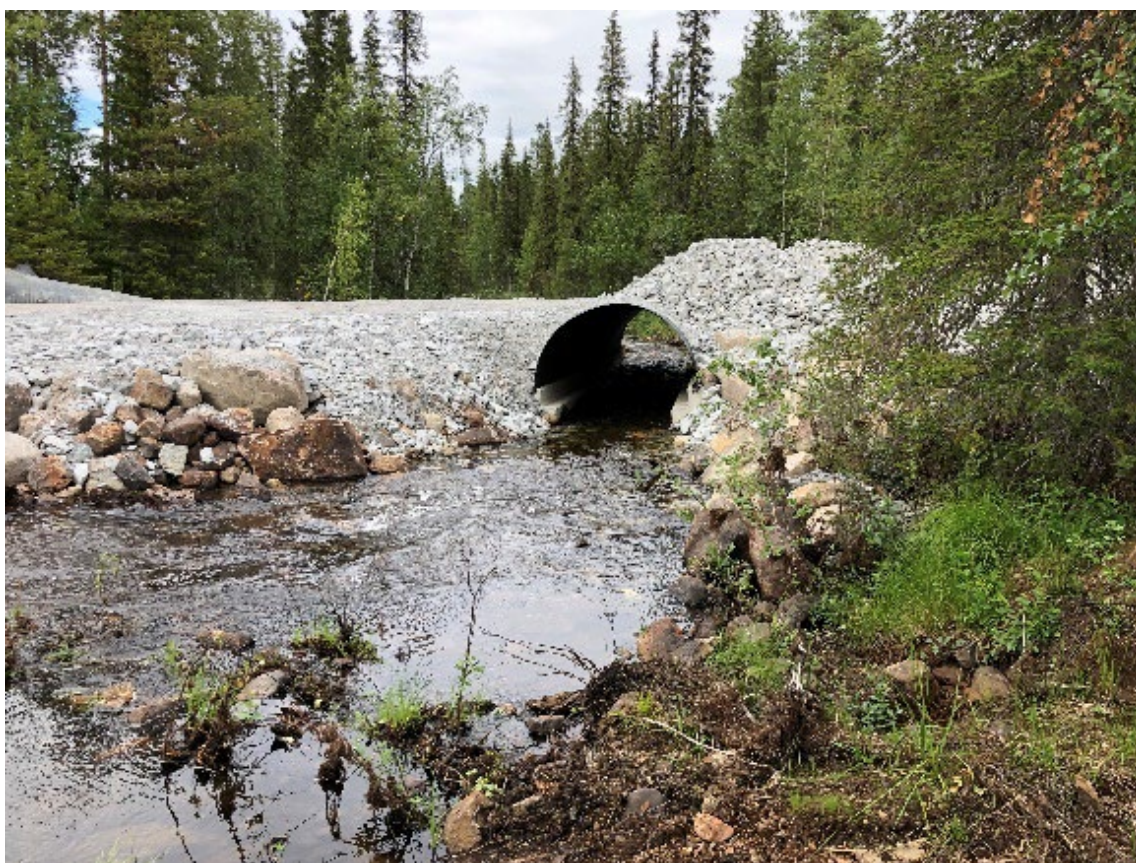
Figure 11. The photos are taken before and after remediation of migration barrier, object 2. A side channel to Pärälven river was reopened in the inlet and the increased waterflow required a wider bridge adapted to high water velocities and to avoid a too steep incline. Photo: County Administration Board.

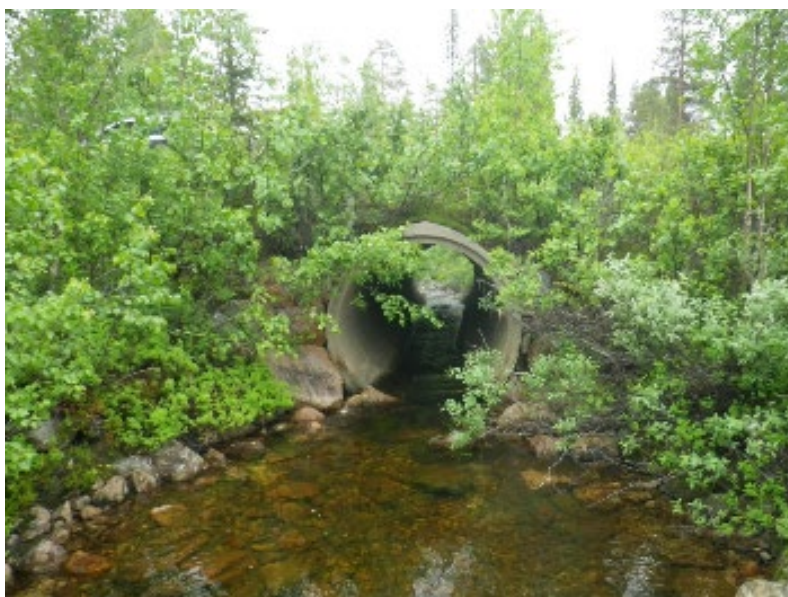
Figure 12. The photos are taken before and after remediation of migration barrier, object 3. The old bridge had narrowed the water stream significantly. After remediation the water stream have regained the original width, also note that now bottom substrate is presence. Photo: County Administration Board.

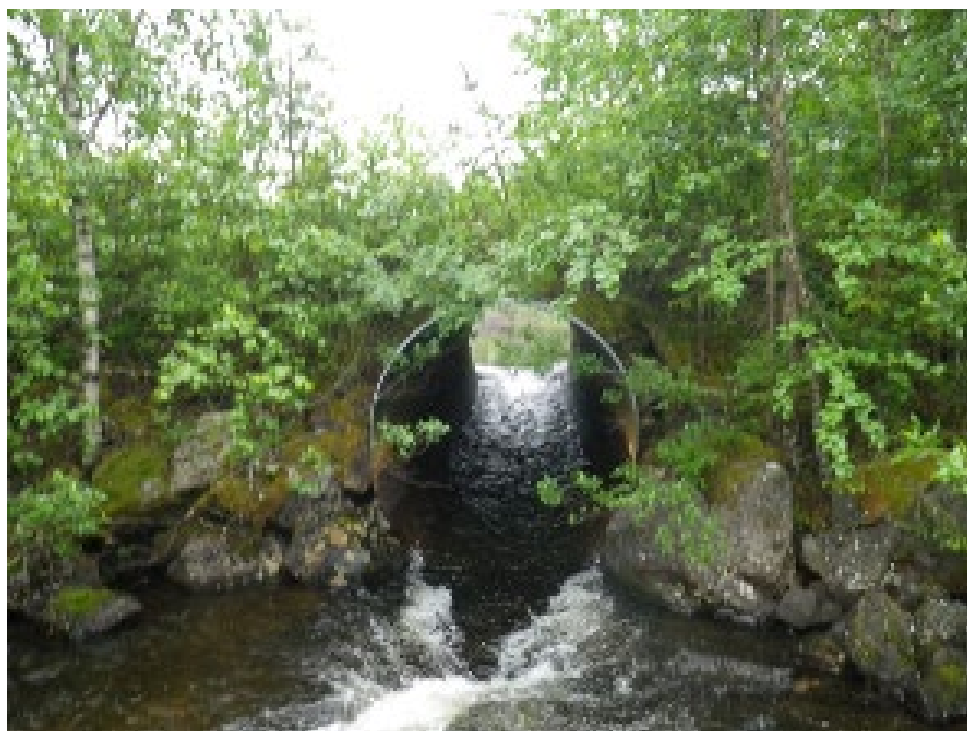
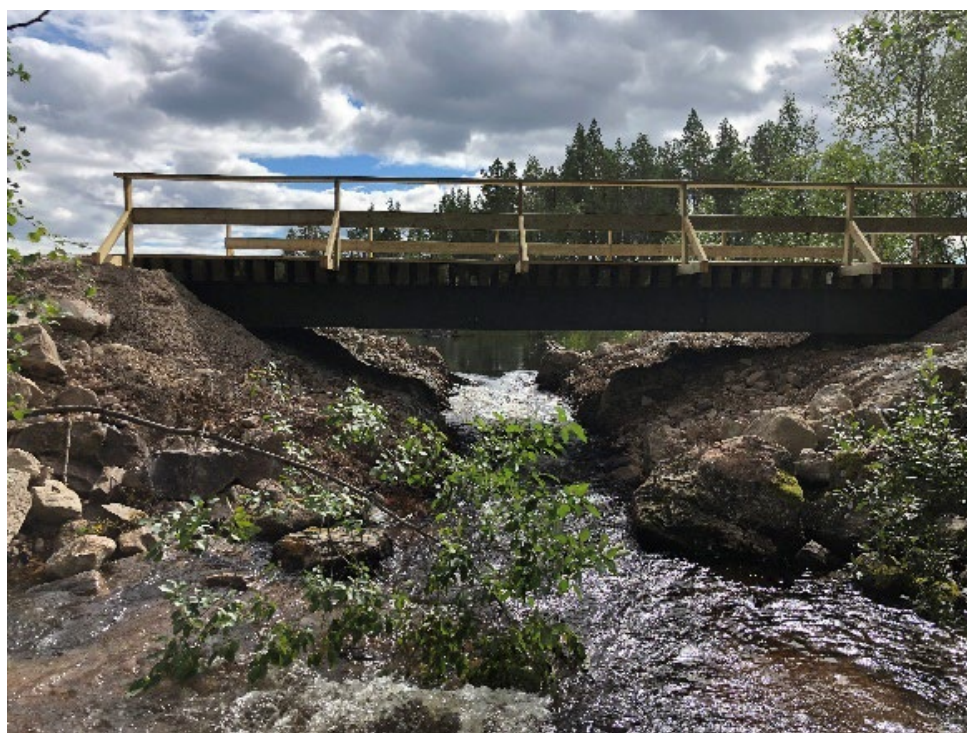
Figure 13. The photos are taken before and after remediation of migration barrier object 4. The old bridge had narrowed the water stream significantly. After the new bridge has been installed the water stream is wider. Photo: County Administration Board.

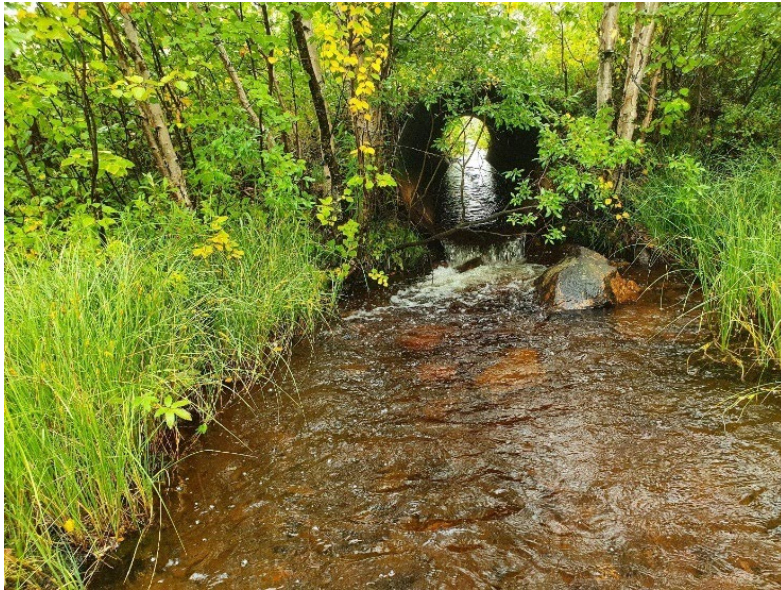
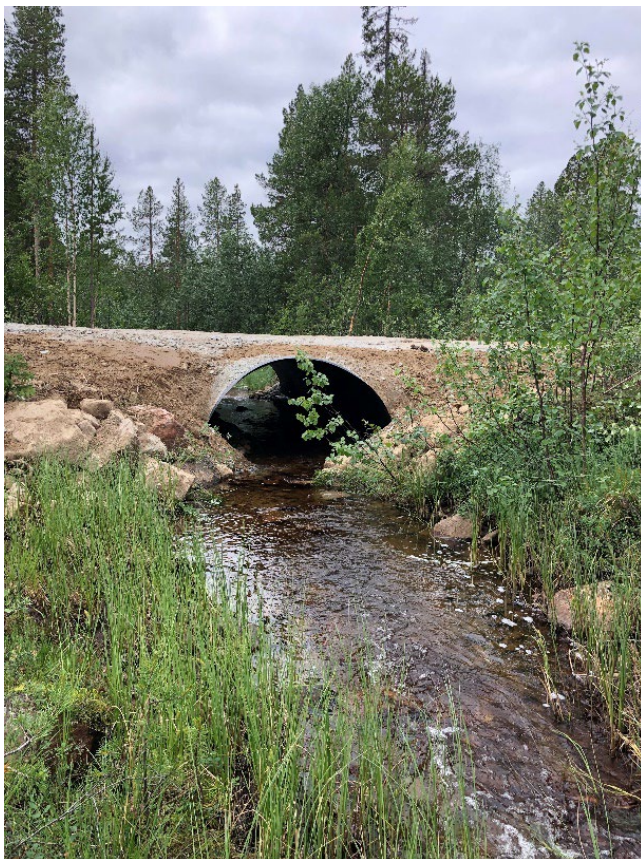
Figure 14. The photos are taken before and after remediation of migration barrier object 5. The old culvert was too narrow and the lack of bottom substrate didn't offer any resting size for fish. After remediation the water stream is wider. Inside the arch there is now the presence of bottom substrate together with bigger stones. Photo: County Administration Board.

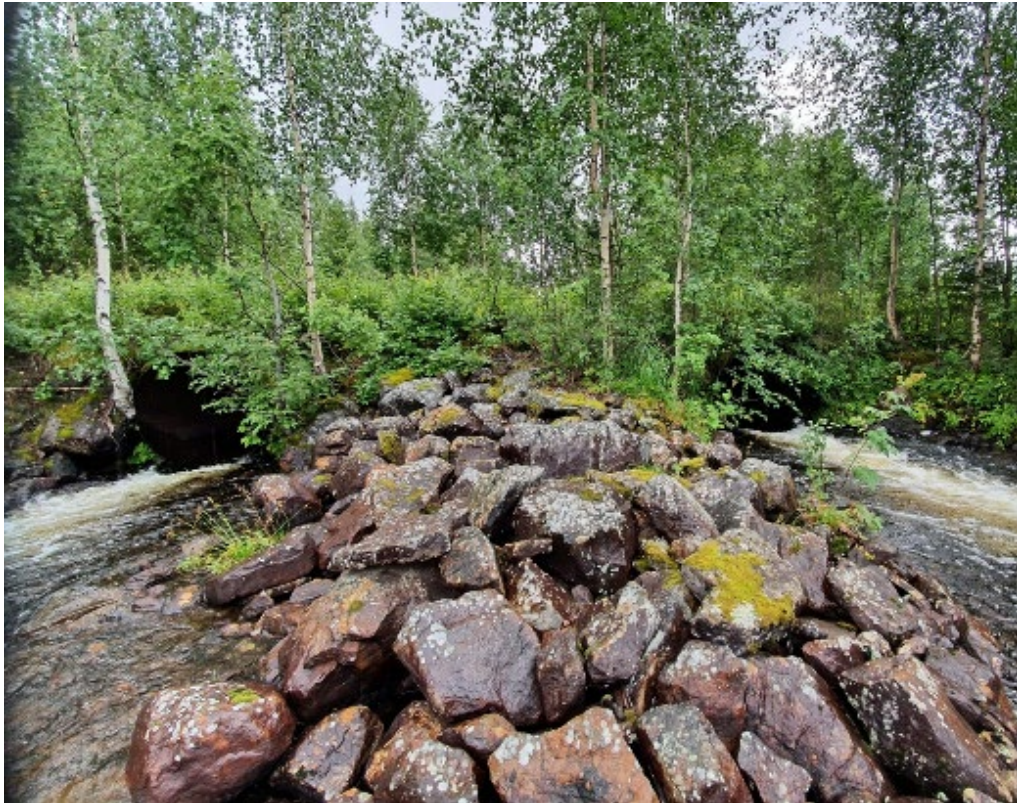
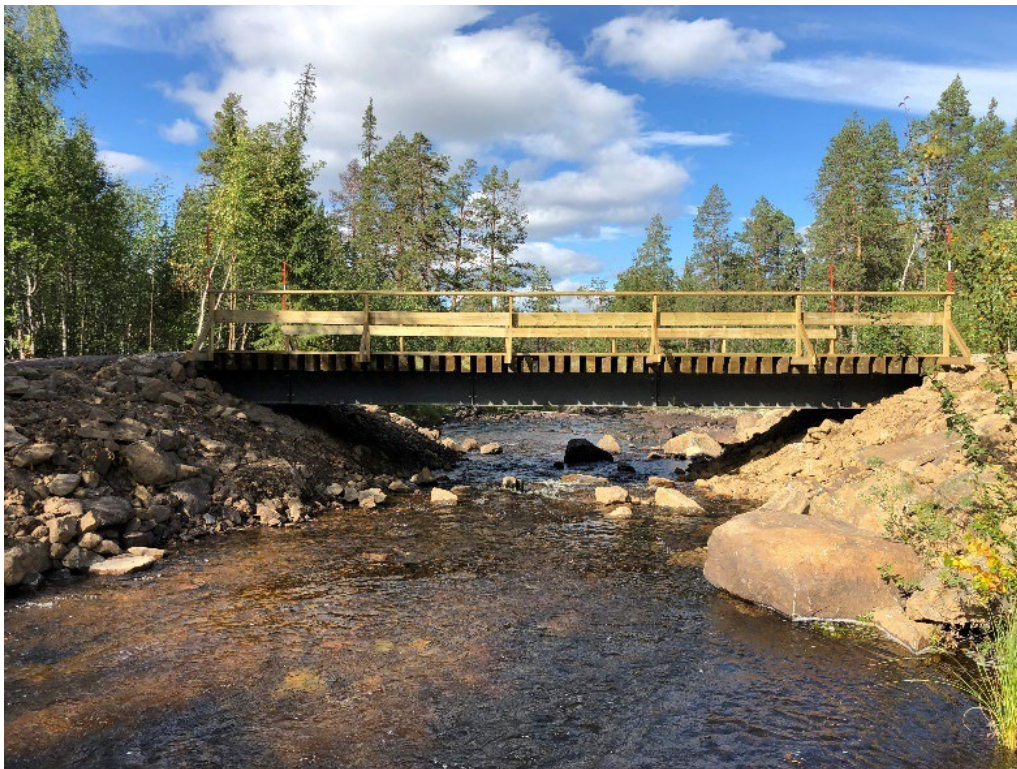
Figure 15. The photos are taken before and after remediation of migration barrier object 6. Before the remediation the bridge was too narrow, and it created a too high water velocity. After remediation the water velocity has decreased, the stream has regained its width and under the bridge there is now bottom substrate in different sizes. Photo: County Administration Board.

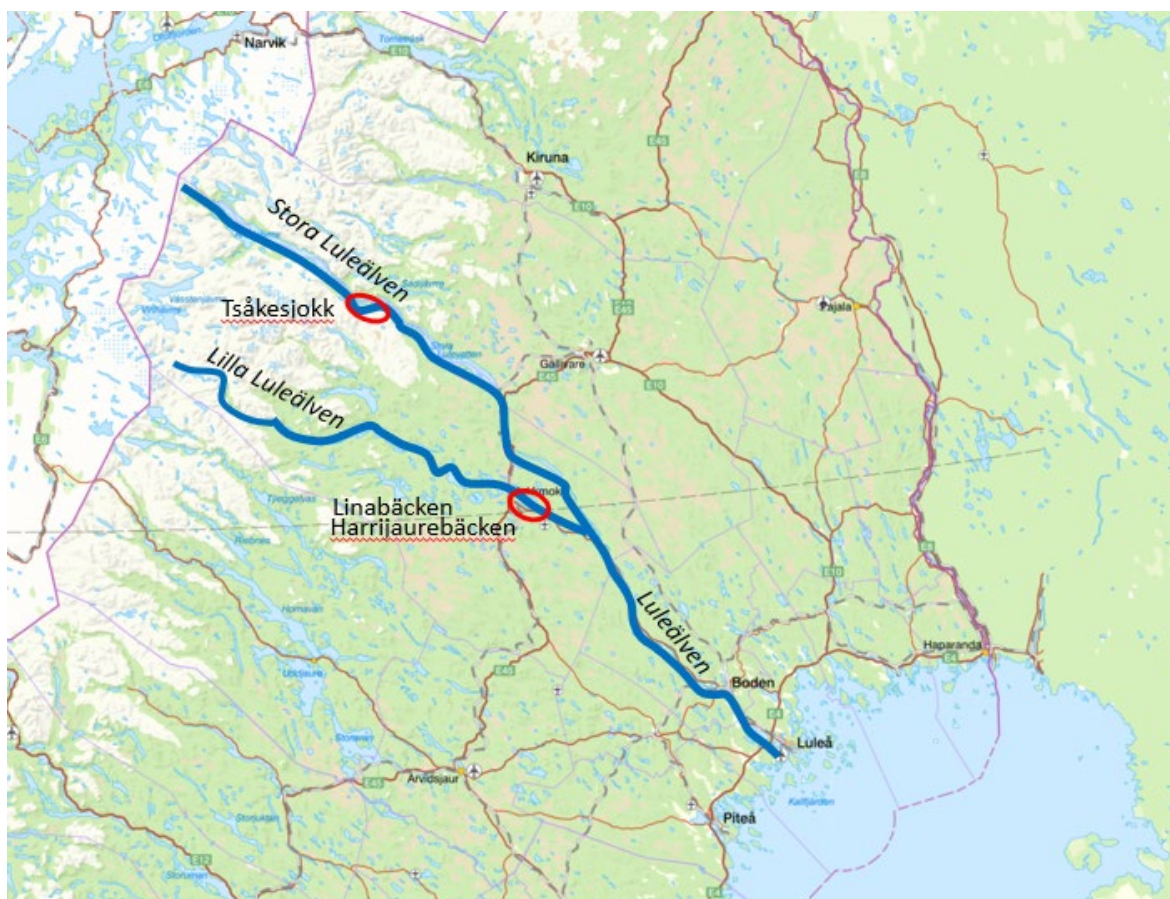
Figure 30. Map of the survey sites (red circles) for the fish migration survey in Tsåkesjokk in the Stora Luleälv and in Linabäcken and Harrijaurebäcken in the Lilla Luleälv. Map from Norrbotten county's internal web GIS.

Fish migration survey was carried out in Linabäcken and Harrijaurebäcken, which enters into the reservoir Letsi in Lilla Luleälven, and in Tsåkesjokk, which enters into lake Langas in Stora Luleälven (figure 30). The reservoir Letsi and Langas have a water level amplitude of 4.7 meters and about 1 meter respectively (information Vattenfall AB).

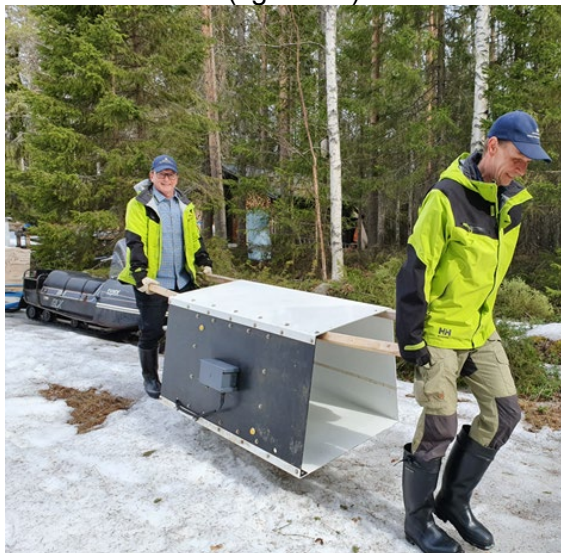
Figure 31. The fish counter consists of a photo tunnel (the white box) with a mounted camera (the gray box on the black side wall) and two lights tubes on the inside. Photo County Administrative Board in Norrbotten.

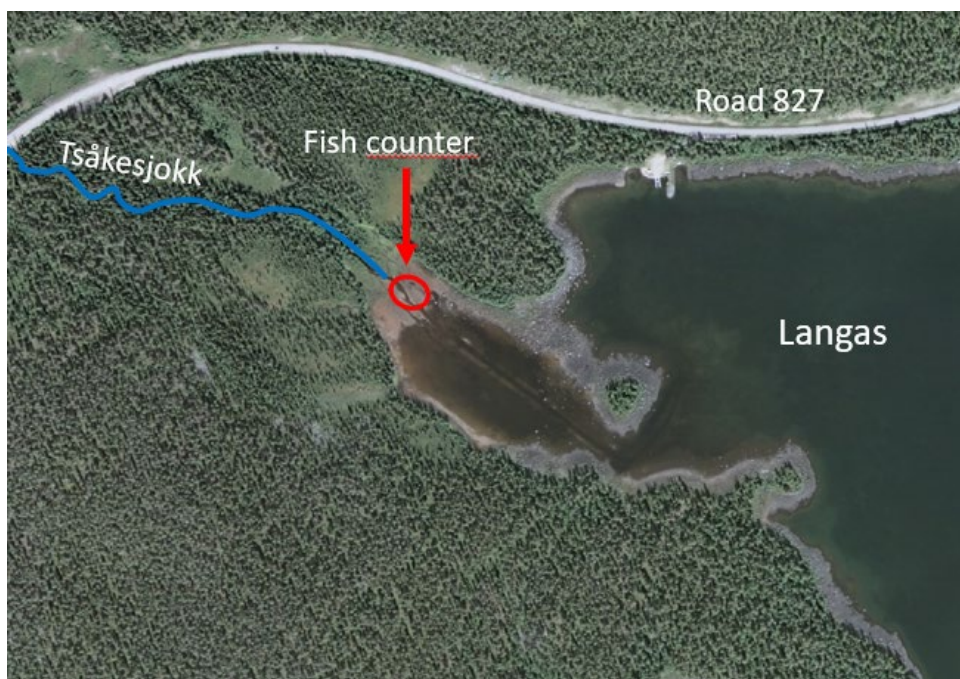
Figure 32. The red circle indicates the position where the fish counter was installed in Tsåkesjokk in 2021. Orthophoto from the County Administrative Board's web-GIS.

Tsåkesjokk flows into lake Langas, which has a regulation amplitude of about 1 meter which is regulated through Langas' outflow via Jaurekaska to Stora Lulejaure and which should be 27 m³/s. The amount of water transferred is regulated by operation of Vietas hydropower plant. The average water flow in Tsåkesjokk is 0.2 m³/s. In the project, an electronic fish counter, Simsonar FC (Simsonar Oy), was installed in the Tsåkesjokk estuary to primarily study the grayling (*Thymallus thymallus*. L.) spawning migration during the spring 2021 (figure 32).

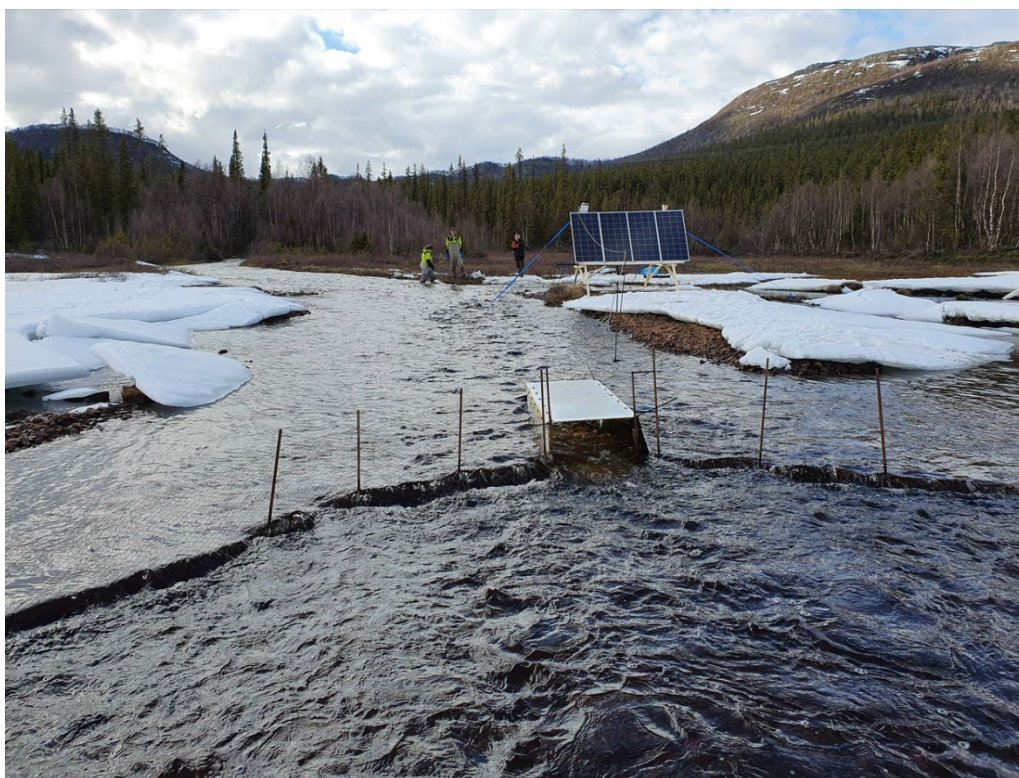
Figure 33. Installed fish counter Simsonar FC with entry fence guiding fish into the fishcounter in Tsåkesjokk and solar panels for recharging batteries on May 26, 2021. Photo: Norrbotten County Board.

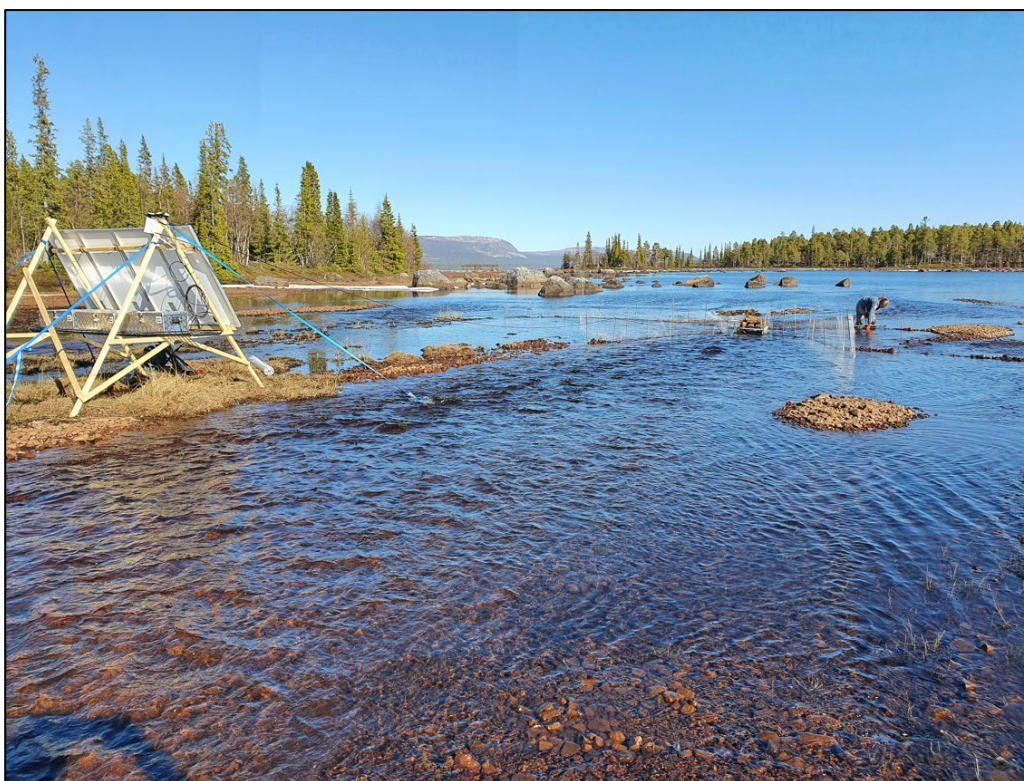
Figure 34. The fish counter, Simsonar FC, reinstalled on 29 May because the counter was moved due to high water pressure. Guide nets were also installed to guide fish during downstream migration. Battery storage as well as PC and router for internet connection were stored in the light metal boxes on the back of the solar panels. Photo: County Administrative Board in Norrbotten.

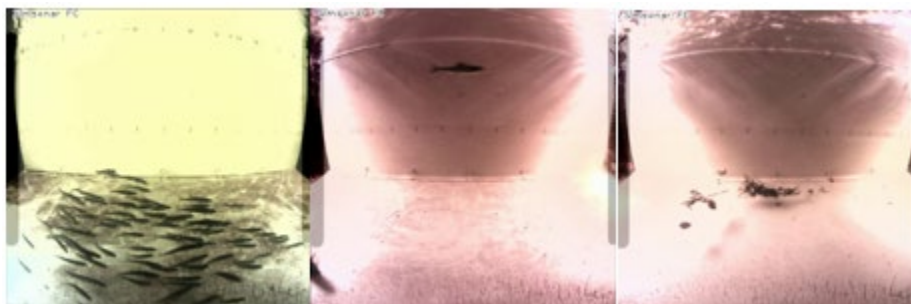
Figure 36. Example of auto-registered upstream and downstream passages of fish and downstream drifting vegetation in the fish counter in Tsåkesjokk's outlet in 2021. Photo: Administrative County in Norrbotten.

No fish passed from 26/5 at 17:00 to 27/5 at 17:07. From 29/5 at 12:32 until 21:49 no fish were recorded. On 29/5 at 21:49 the first fish was recorded which was an upstream grayling with a length of 38 cm at a water temperature of 3.13 C°. Four species were recorded in the fish counter, grayling, trout (*Salmo trutta*, L.), pike (*Esoc lucius*, L.) and shoals of fry probably grayling or whitefish (*Coregonus lavaretus*, L.) (figure 35 and 36).

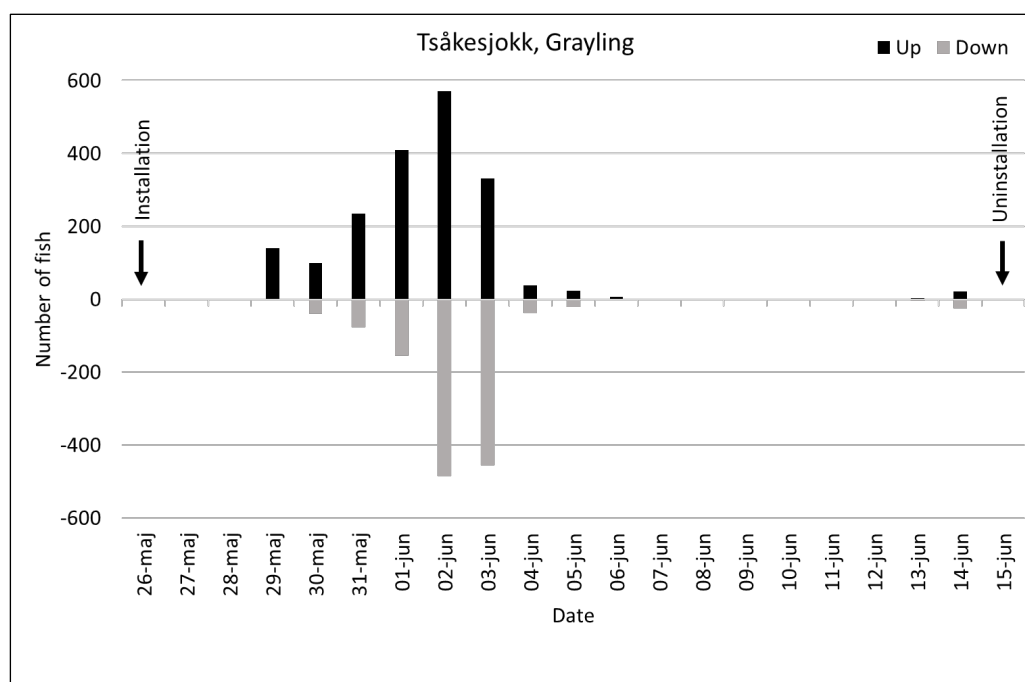
Figure 37. Number of graylings migrating upstream and downstream (positive numbers indicate upstream and negative numbers indicate downstream) that were registered in the fish counter in the Tsåkesjokk outlet in 2021.

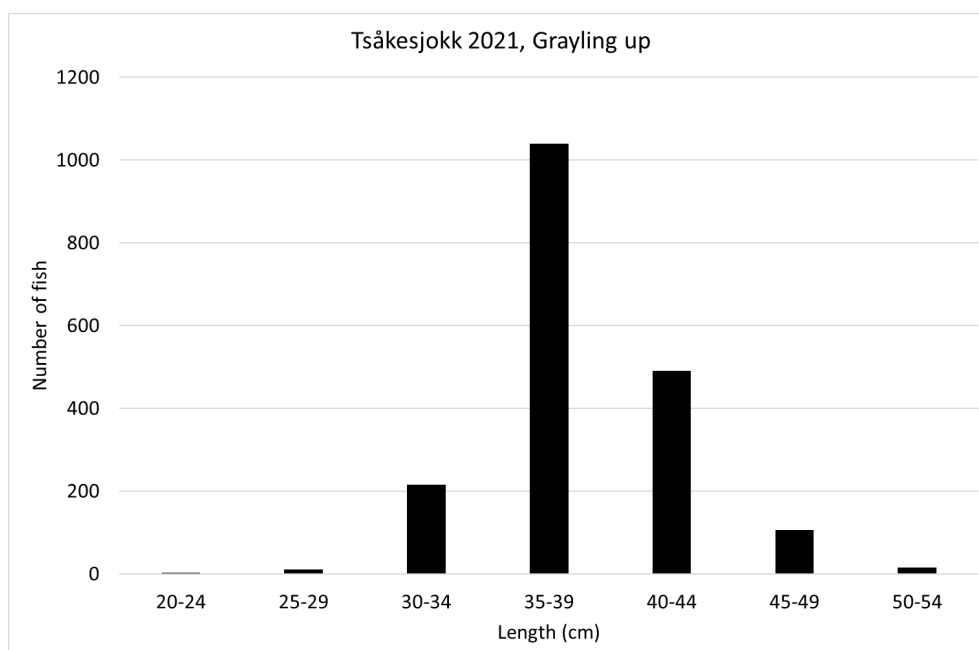
Figure 40. Number of migrating graylings recorded with the fish counter and grouped in 5 cm intervals in Tsåkesjokk in 2021.

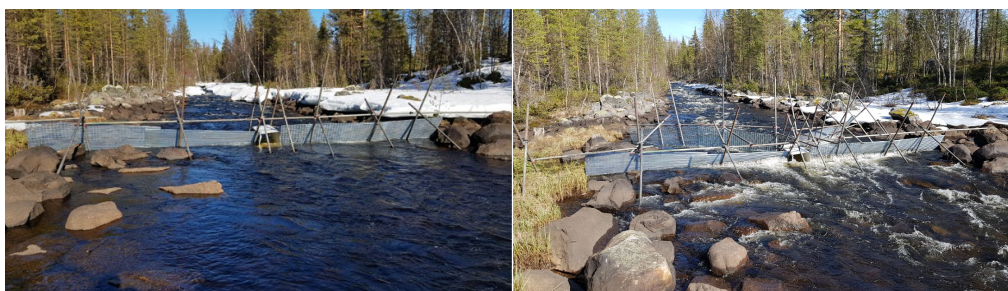
Figure 44. Installation of fish counter in Harrijaruebäcken on May 21 (left) and May 27 (right image) 2020. Photo: Administrative County Board in Norrbotten.

On 21 May 2020, the fish counter was installed in Harrijaurebäcken and the first fish to pass upstream was a perch on 22 May with a length of 34 cm (figure 44). The fishcounter was uninstalled on the 10th of October 2020.

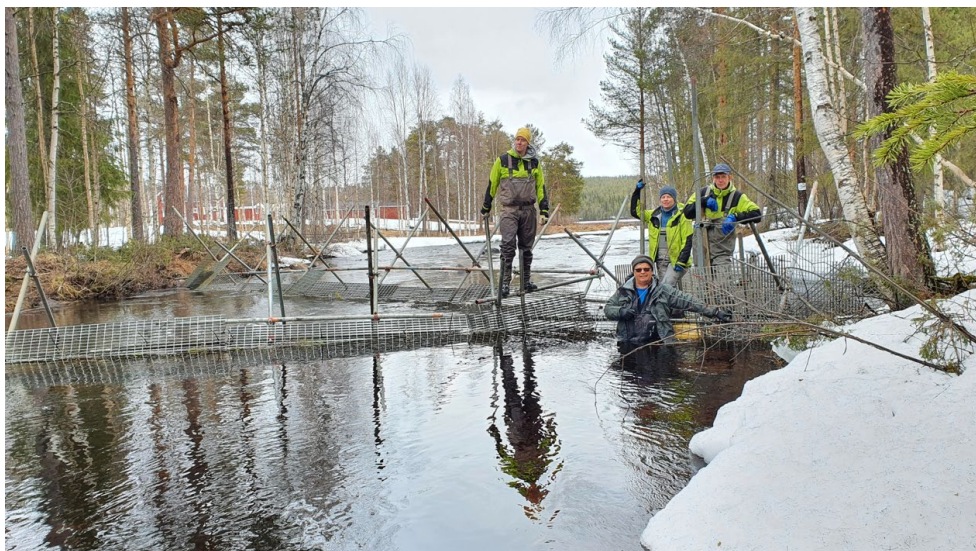
Figure 49. Installation of the fish counter in Linabäcken 2021. Photo: Administrative County Board in Norrbotten.

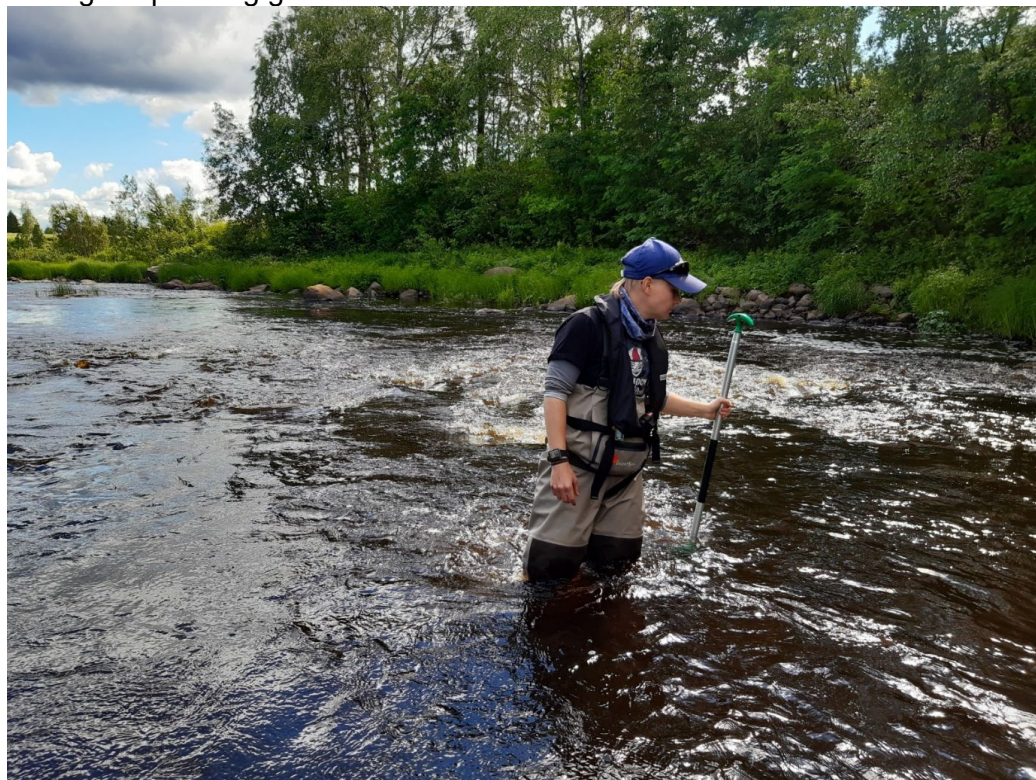
Figure 55. Mapping of the riverbed in the river Vaajoki in the summer of 2021. Photo: Timo Lettijeffer, Lapland ELY-centres.

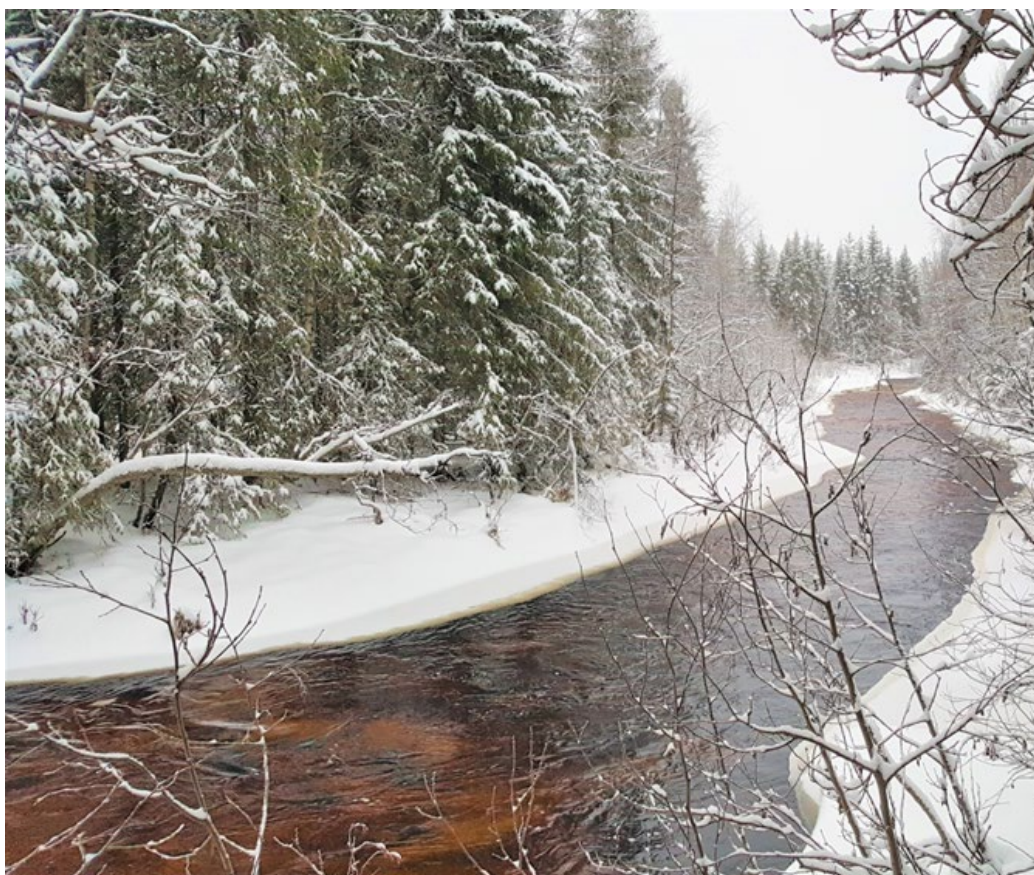
Figure 56. River Vaajoki, whose rapids areas lack stones reaching the surface and the river is frozen at the bottom. The lack of bottom vegetation in Vaajoki is probably due to the freezing of the bottom of the rapids. Photo: Timo Lettijeff, Lapland ELY-centres.

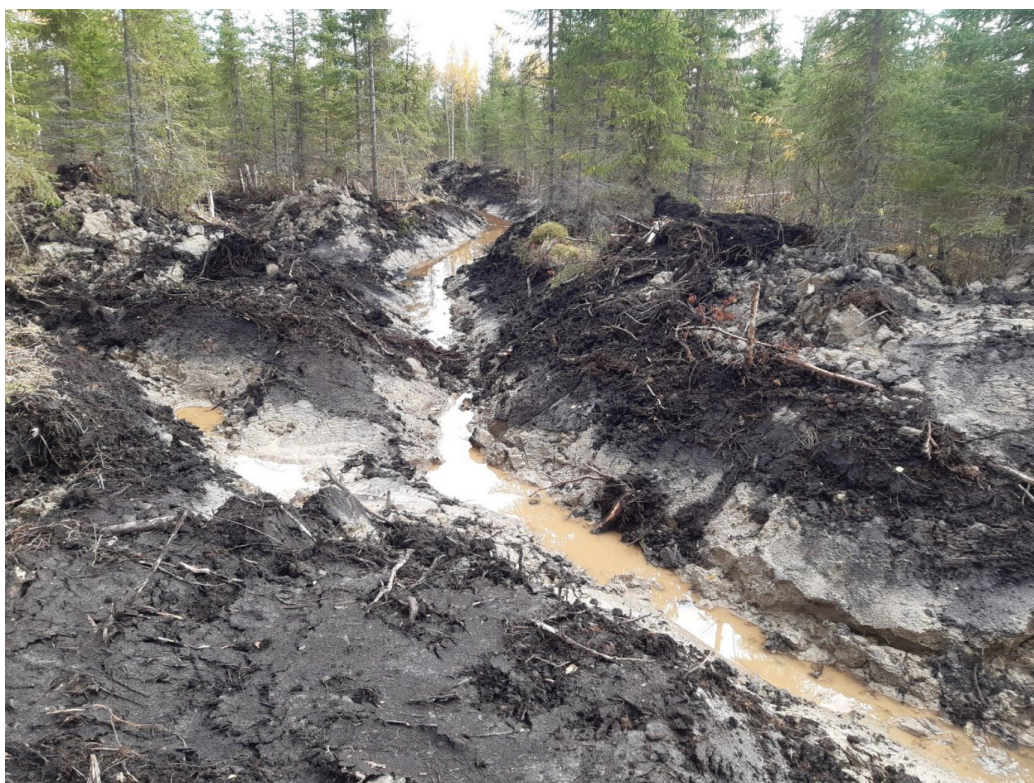
Figure 57. A new forest ditch in the upper part of the Suolijoki river. Photo: Jere Jääskeläinen, Lapland ELY-centres.

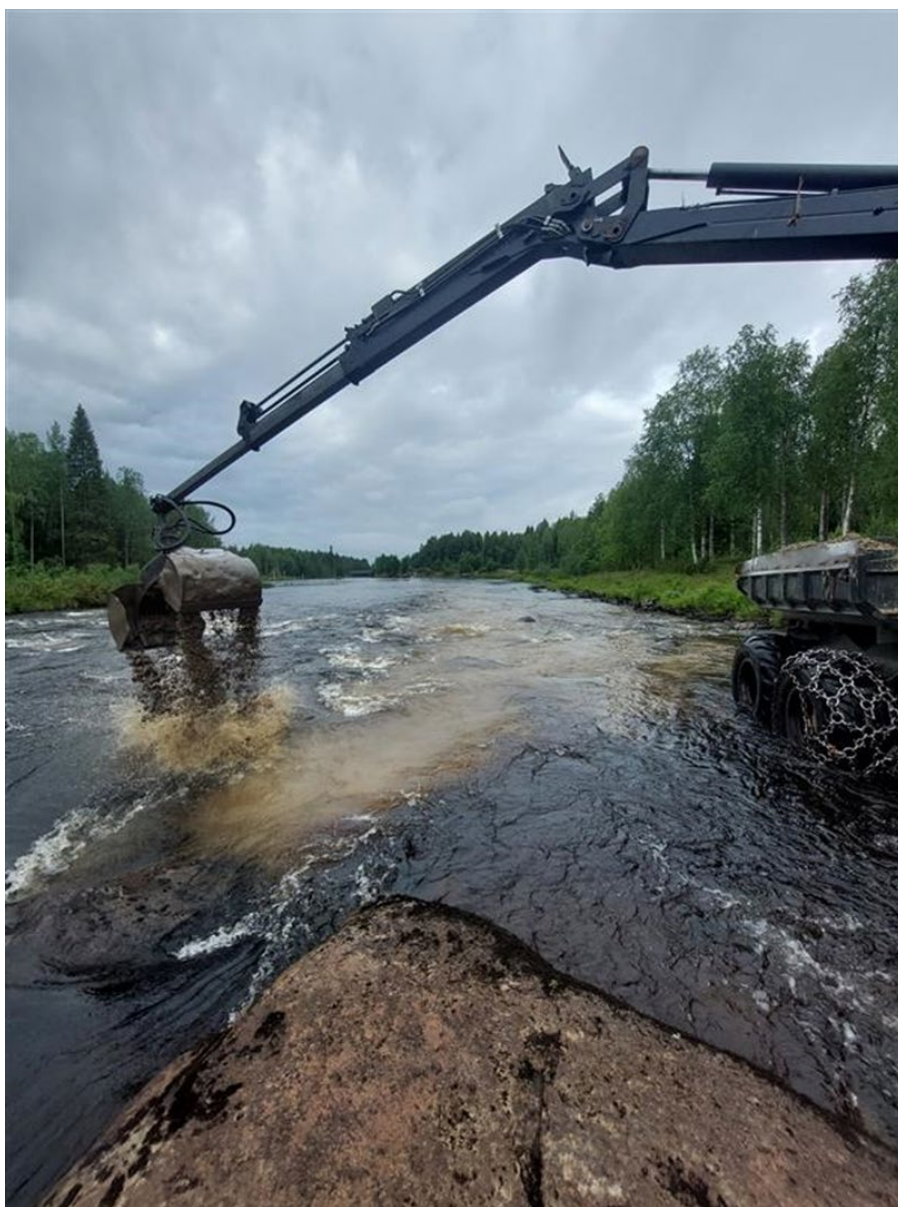
Figure 58. A forestry tractor laying spawning gravel in the Vikaköngäs rapid water sections. Photo: Antero Mölläri, Metsähallitus

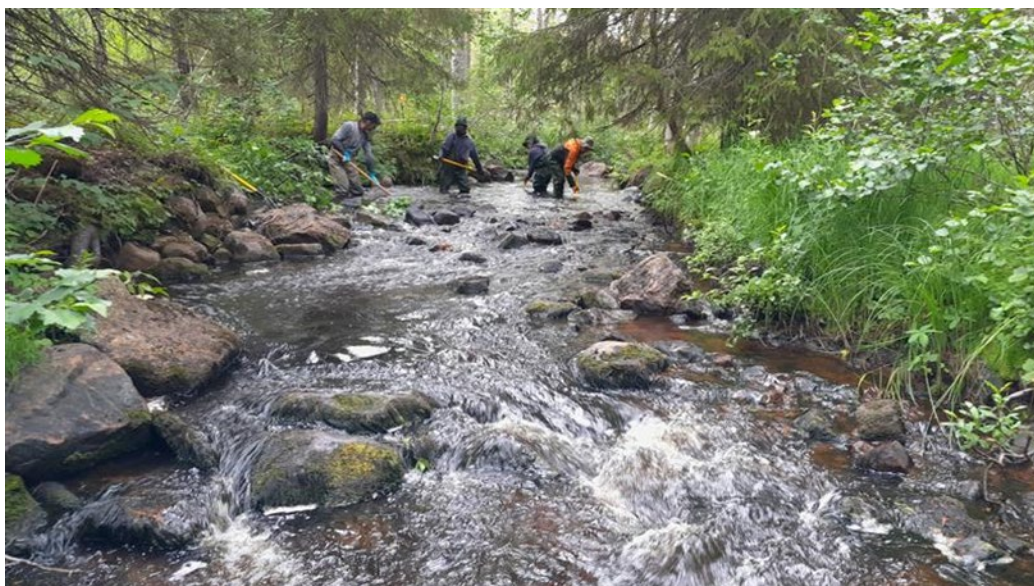
Figure 59. Restoration group in Vaattunkijoki and Silmäjoki was using Hartijoki method and hand tools for restoration actions. Photo: Sihveri Ervasti, Metsähallitus

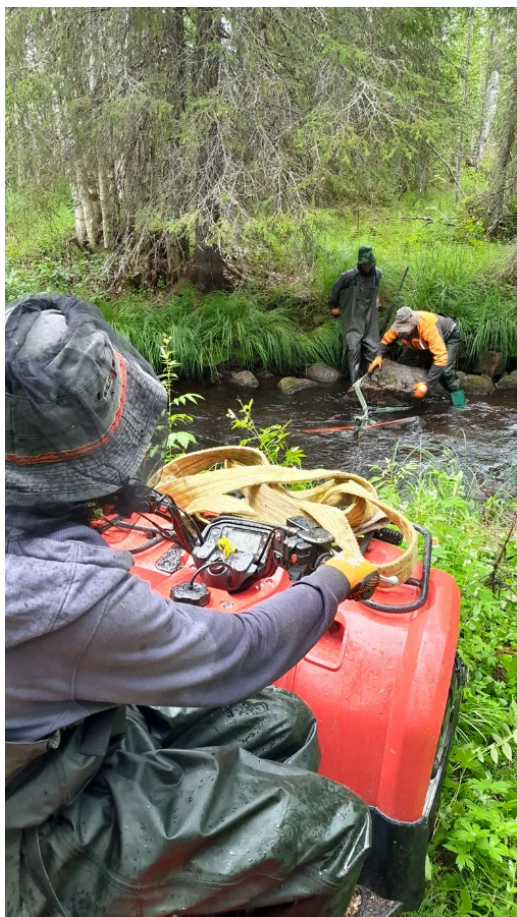
Figure 60. ATV winch can be used for moving bigger boulders. Photo: Markku Vierelä, Metsähallitus

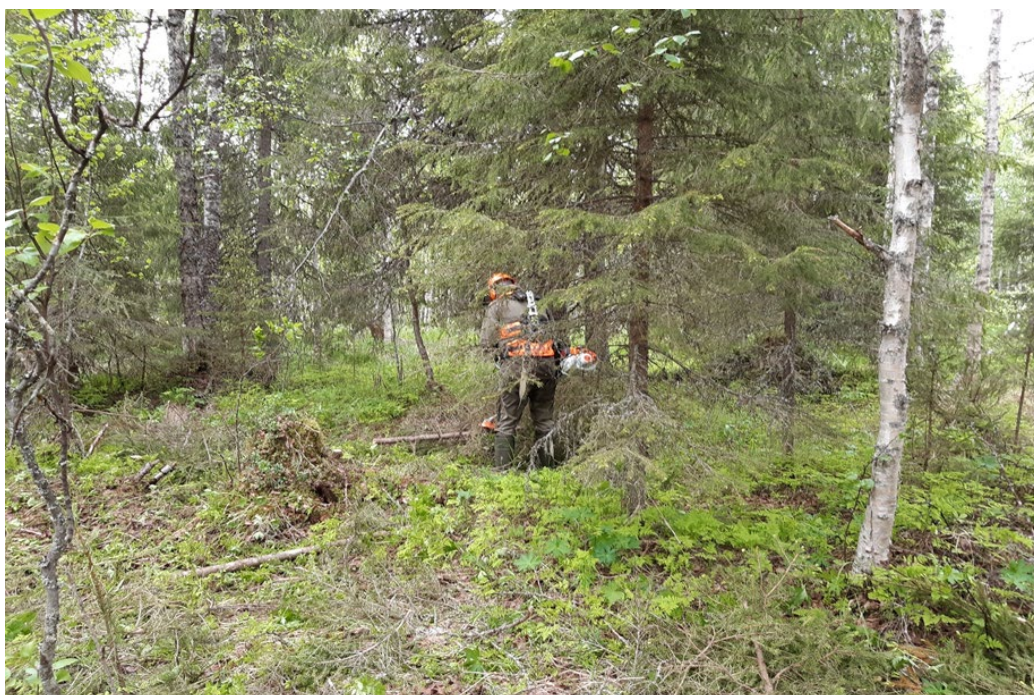
Figure 61. For the tree trunk bundles, spruces were felled from the side of the ditch with a clearing saw. Photo: Reeta Peteri, Lapland ELY-centres.

The pilot site arranged in the EMRA project in the summer of 2022 included five ditches that flow into Suolijoki River over a distance of 4.4 kilometres as the crow flies. The team travelled from one ditch to another by car, then on foot to the work site. A total of 35 bundles of trimmed spruce tied with sisal rope were placed in the ditches. The cost estimate includes labour costs and the price of sisal rope. The cost of the used timber has not been taken into account due to the low cost of small-diameter timber. The approximate joint cost for the site is 773 euros (VAT 0%). The cost per bundle in this case would be about 22 euros (VAT 0%).

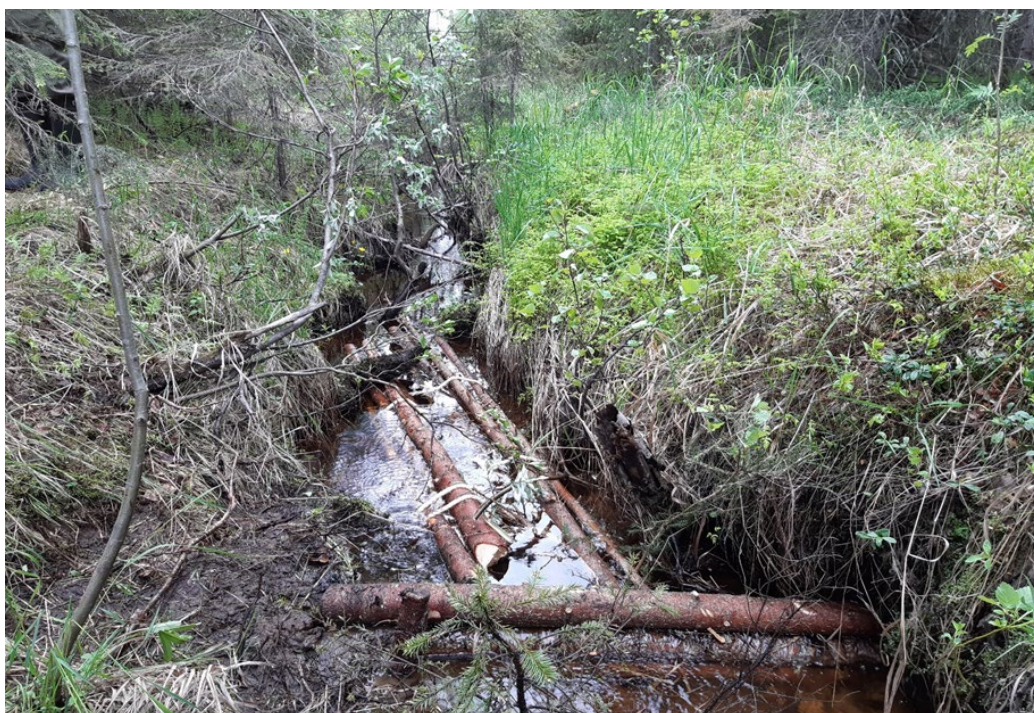
Figure 62. At the bottom dam, the water level in the shallow ditch was raised so that the tree trunk bundles stay below the water level. Photo: Reeta Peteri, Lapland ELY-centres.
