Final report EMRA

Environmental planning, measures and restoration actions in regulated water systems.

A Swedish-Finnish cross-border-project in the arctic region.

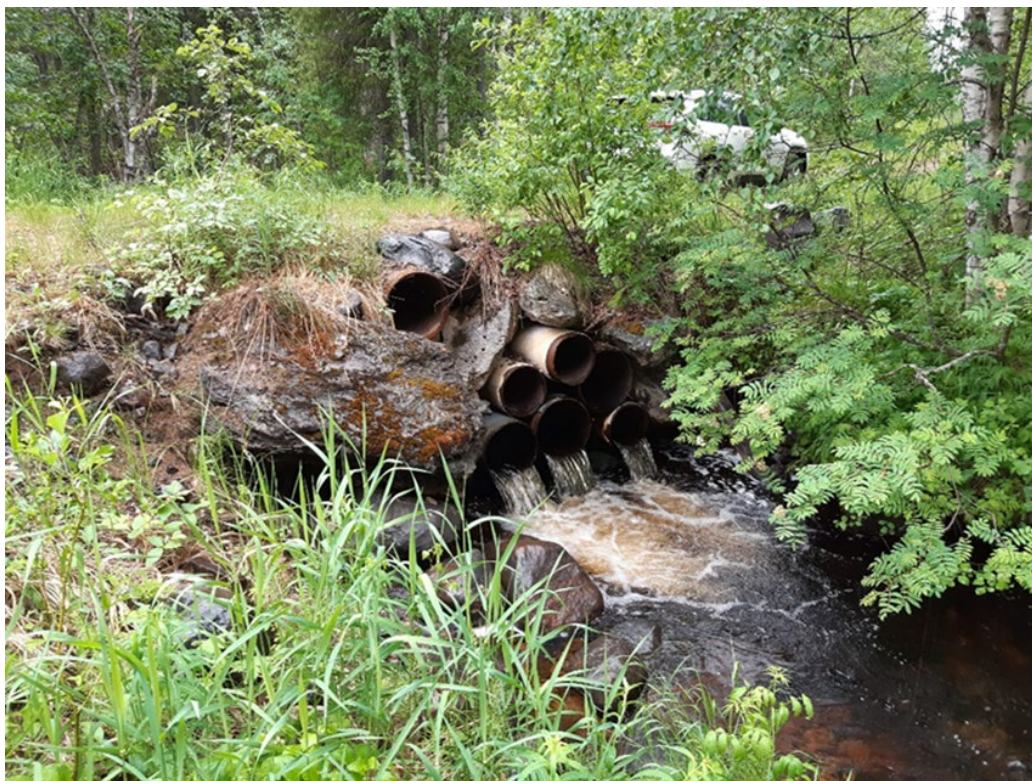
Figure 63. Sihtunajoki's seven-pipe culvert structure viewed from the downstream direction before culvert replacement. Photo: Timo Lettijeffer, Lapland ELY-centres.

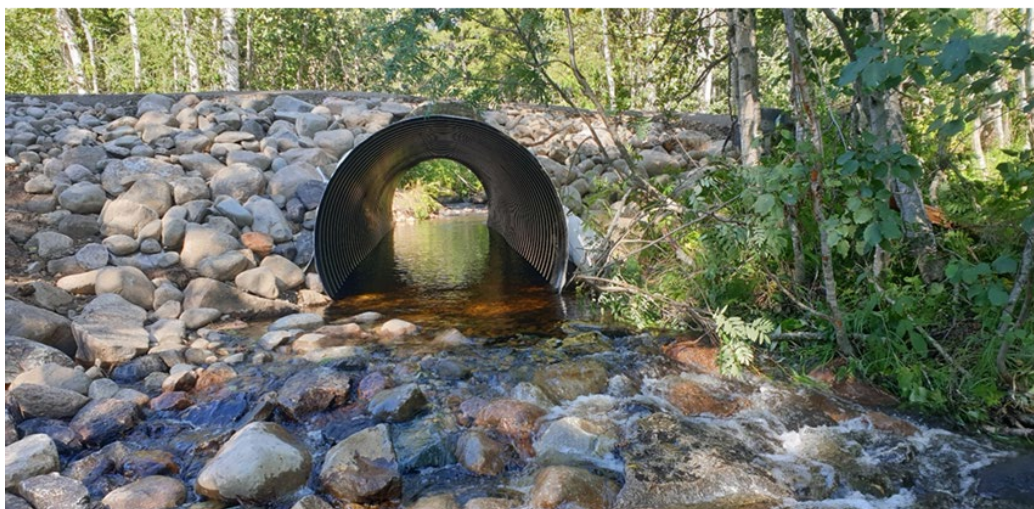
Figure 64. Sihtunajoki culvert after changing. A rapid was also built below to slow down the water flow and raise the water level in the road culvert. Photo: Lapland ELY-centres.

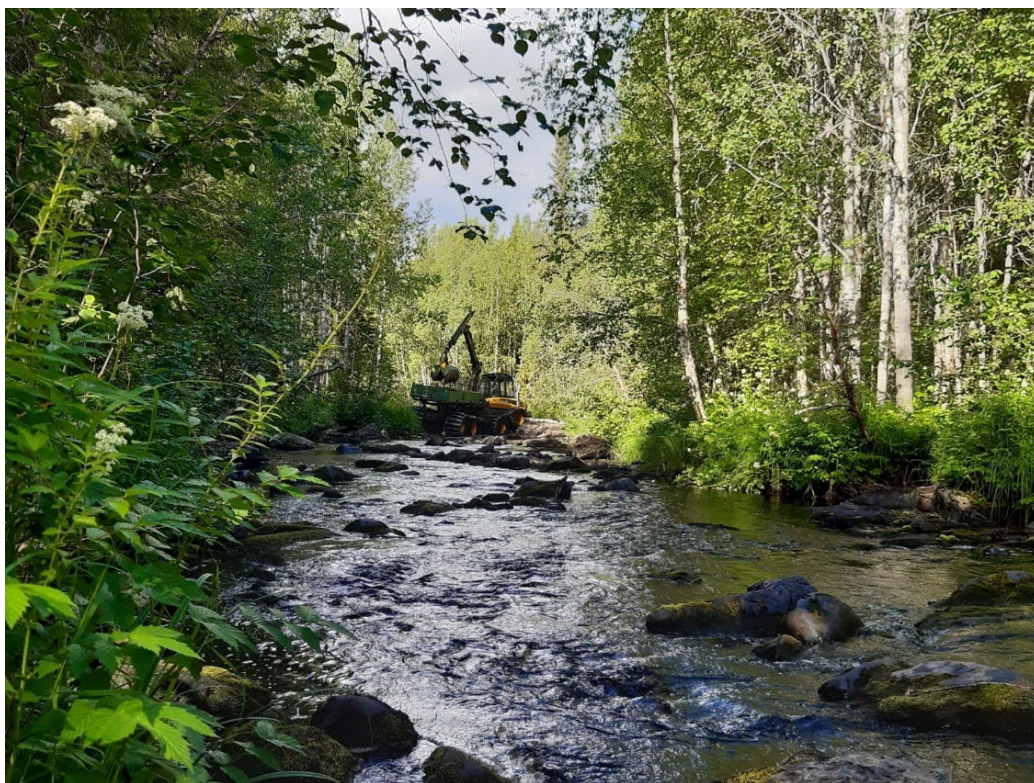
Figure 65. Laying of spawning gravel with a forest tractor in Ropsajoki in the summer of 2022. Photo: Piia Sonkajärvi, Lapland ELY-centres.

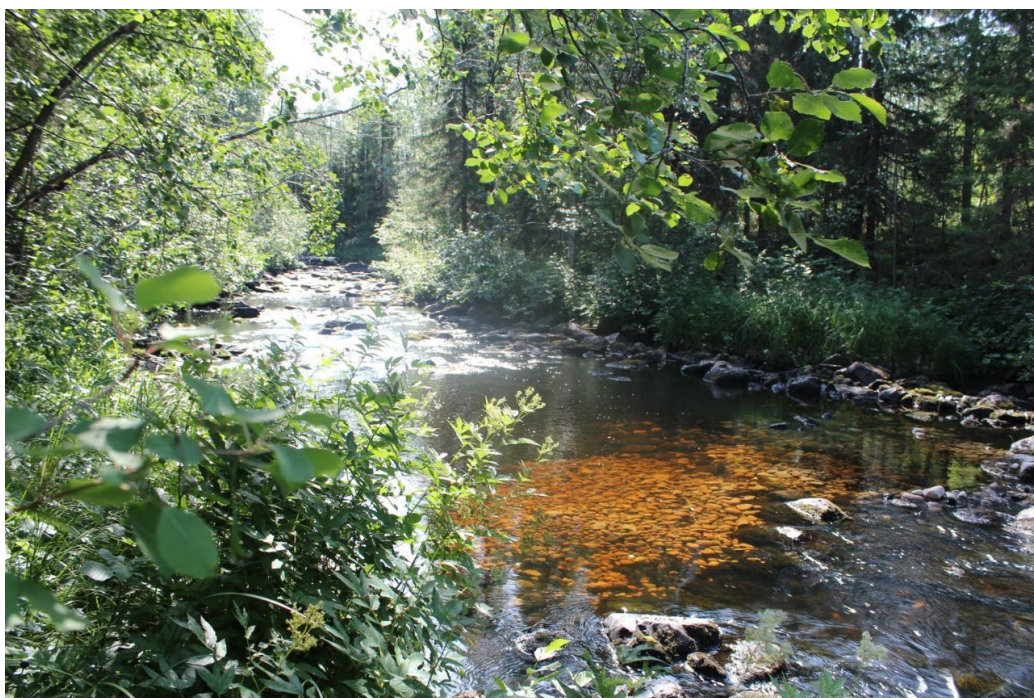
Figure 66. New spawning gravel in Ropsajoki. The color of gravel will darken in a few years. Photo: Piia Sonkajärvi, Lapland ELY-centres.
