Coastal watercourses

Methodological Development and Restoration

Title: Coastal watercourses - Methodological
Development and Restoration

Publication No: 6/2019

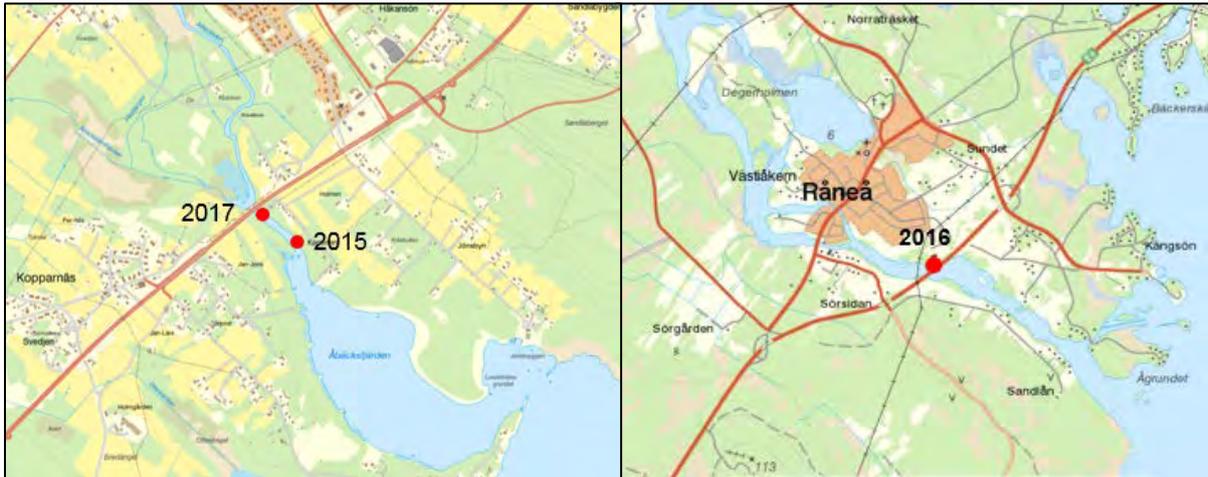
Figure 1.3. Map of the lower reaches of the Alterälven and Råneälven rivers upstream of where they run into the sea, with the red dots indicating the installation site and year of fish migration monitoring using ultrasound cameras in 2015, 2016 and 2017.

The migration of the whitefish was monitored in the lower reaches of the Alterälven river in 2015 and 2017, and in the lower reaches of the Råneälven river (reference) in 2016 (Figure 1.3). Behind the choice of location was finding the optimal ultrasound camera site and getting close enough to the mouth of the river to obtain information about the total upstream migration of whitefish.

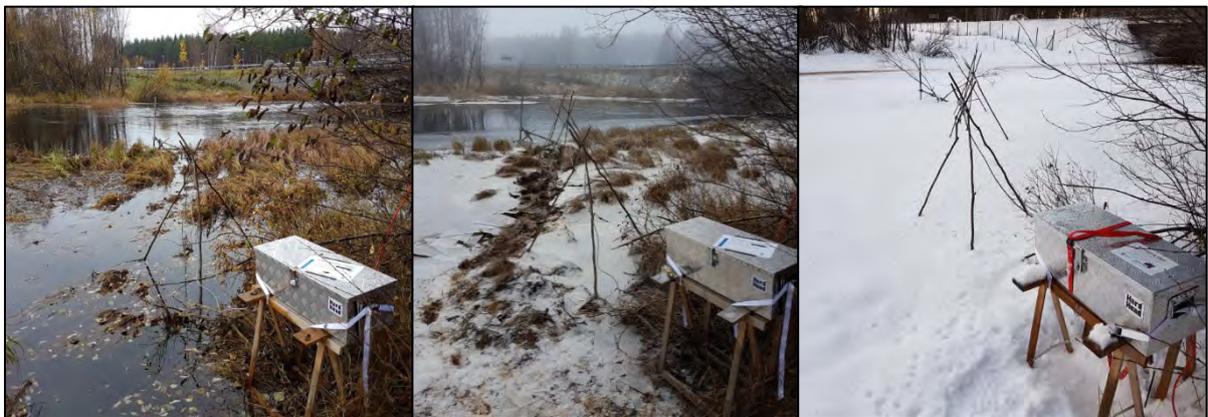
Figure 1.7. The 2017/2018 installation site for the monitoring of upstream migration of whitefish and burbot in the Alterälven river.

In 2017 the installation in the Alterälven river was moved about 200 meters upstream to the area just downstream of the E4 bridge. This was because there was a power supply for the equipment available from the Pite municipality pumping station at the bridge, and the area is somewhat deeper allowing for better study of burbot migrating to their spawning grounds as monitoring migration takes place under the ice. The area immediately downstream of the bridge is a spawning ground for whitefish and probably burbot as well; this resulted in a higher number of logged upstream and downstream fish movements than for 2015 site about 200 meters downstream in an area with a faster current, where it is unlikely that spawning takes place due to the high water speed.

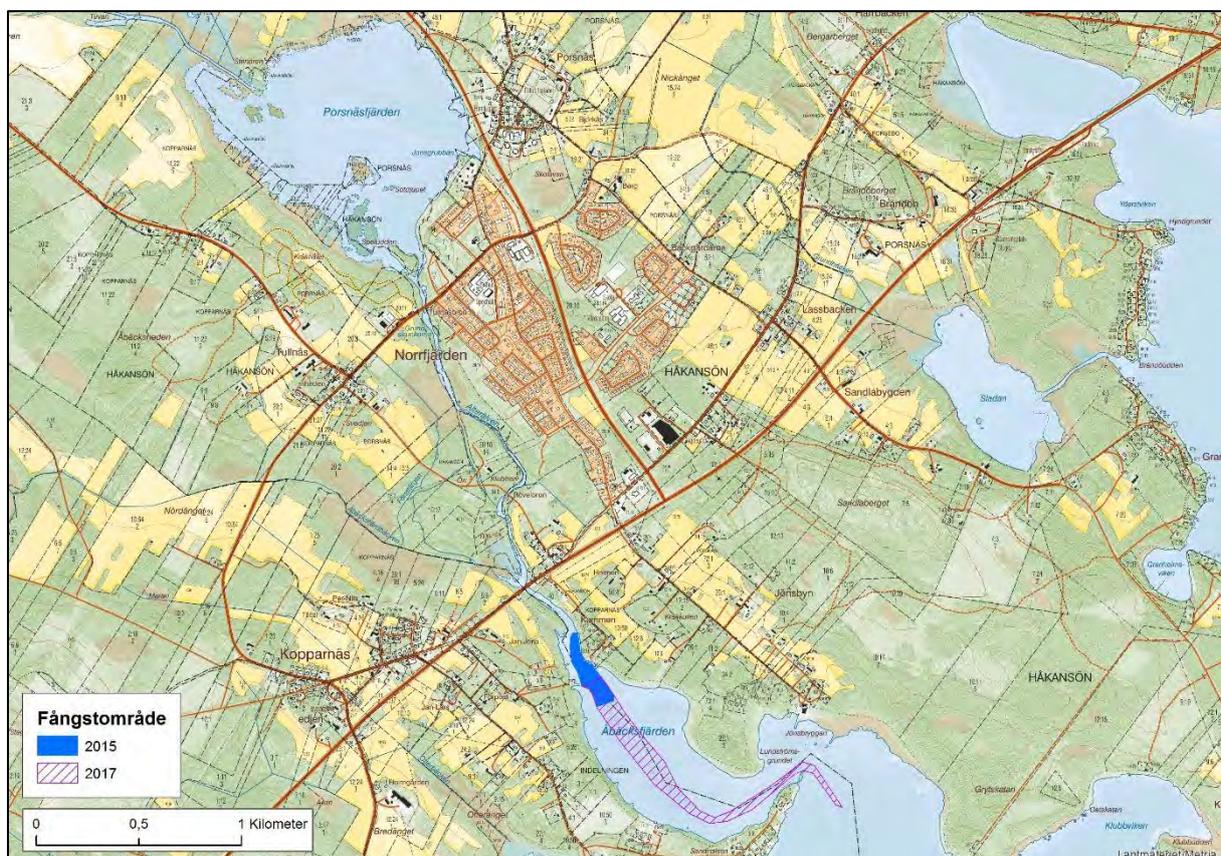
Figure 2.1. Map of the catch areas in the Alterälven river in 2015 and 2017.

Whitefish for tagging were caught at the mouth of the Alterälven river. After tagging the whitefish were released just upstream of the catch area. See Figure 2.1.

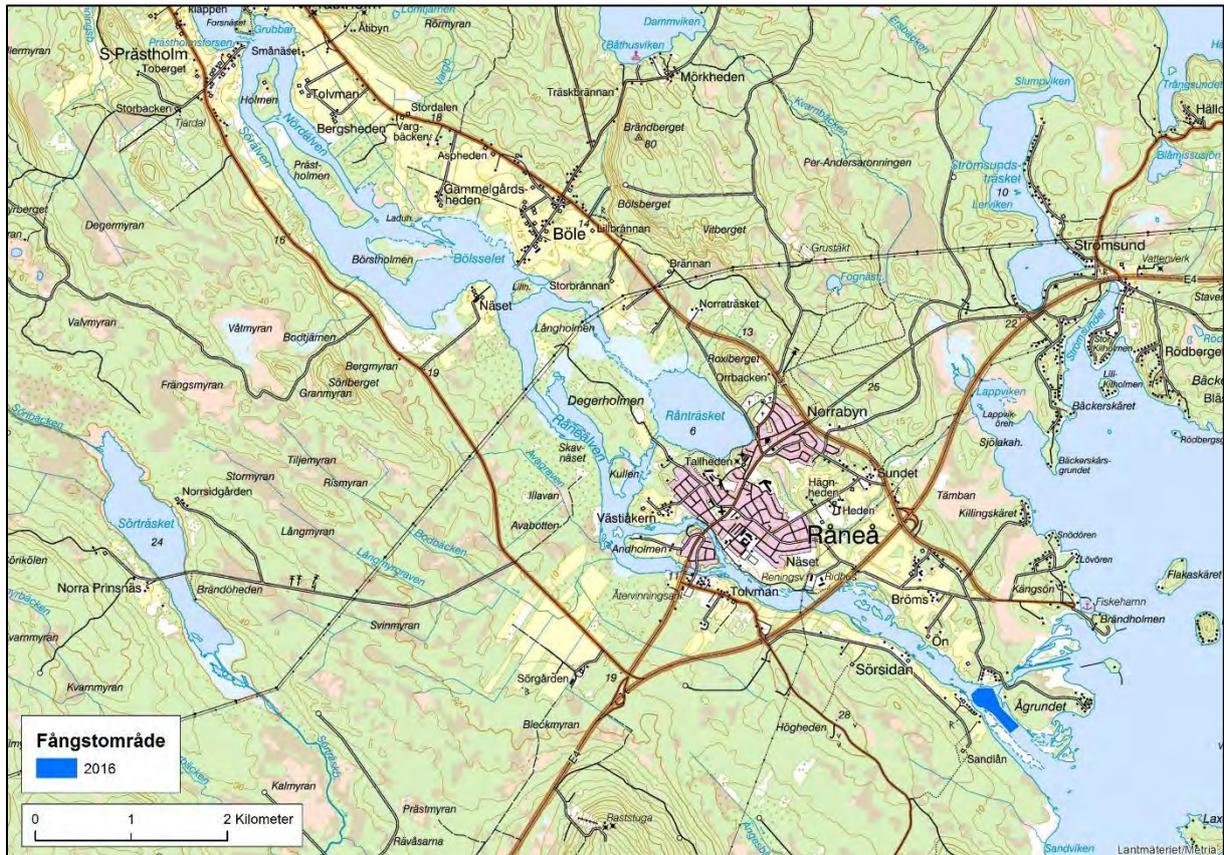
Figure 2.2. Map of catch areas in the Råneälven river 2016.

In the Råneälven river, the whitefish for tagging were caught in the calm water downstream of the lowermost rapids. After tagging the whitefish were released just upstream of the catch area. See Figure 2.2.

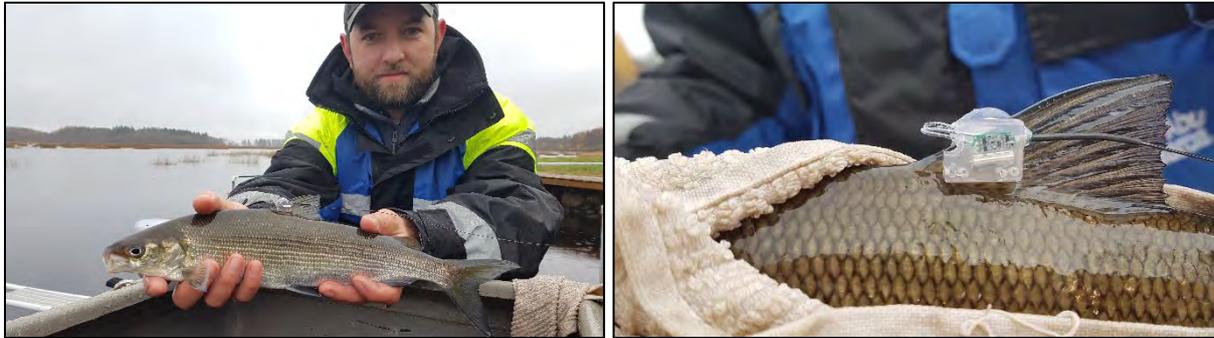
Figure 2.4. Photograph of a whitefish with a radio transmitter mounted over the dorsal fin.

The radio transmitters were attached over the dorsal fins of the whitefish with the transmitter battery side to the right of the fish and the transmitter electronic side and antenna to the left of the fish (Figure 2.4).

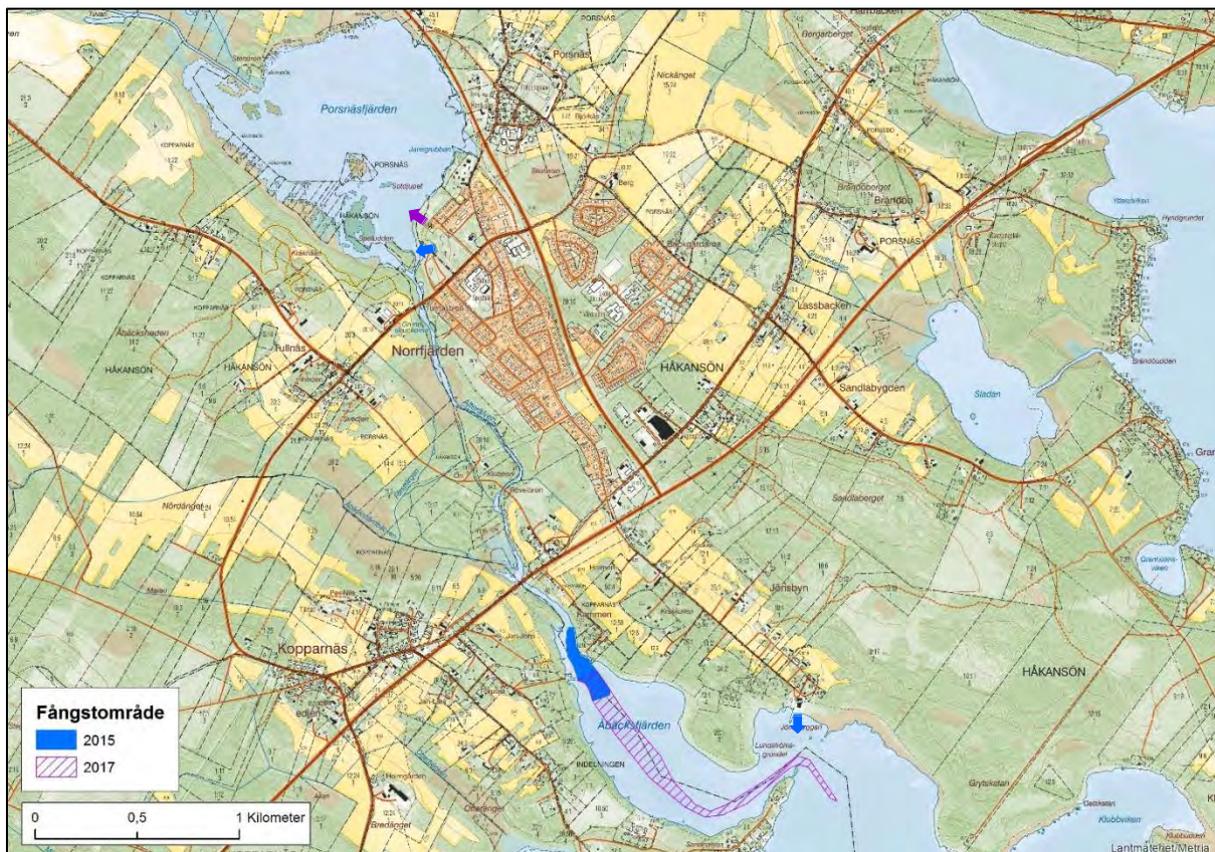
Figure 2.5. Map of the Alterälven river and the positioning of the telemetry study in 2015 and 2017. Blue arrows show the positions of fixed receivers and the direction of antennae in 2015 and 2017. The purple arrow shows the position and direction of the extra antenna used during the 2017 study to increase resolution at the modified migration barrier.

In the Alterälven river two stationary receivers were used to log tagged whitefish. One at the mouth of the river and one at the outlet of the Porsnäsfjärden lake. During the 2017 study a switch box was used by the receiver at the Porsnäsfjärden lake so that an additional antenna could be used. We did this to increase resolution and detect whether tagged whitefish passed the migration barrier on which remedial work had been carried out. See Figure 2.5 for the set up and positioning of antennae.

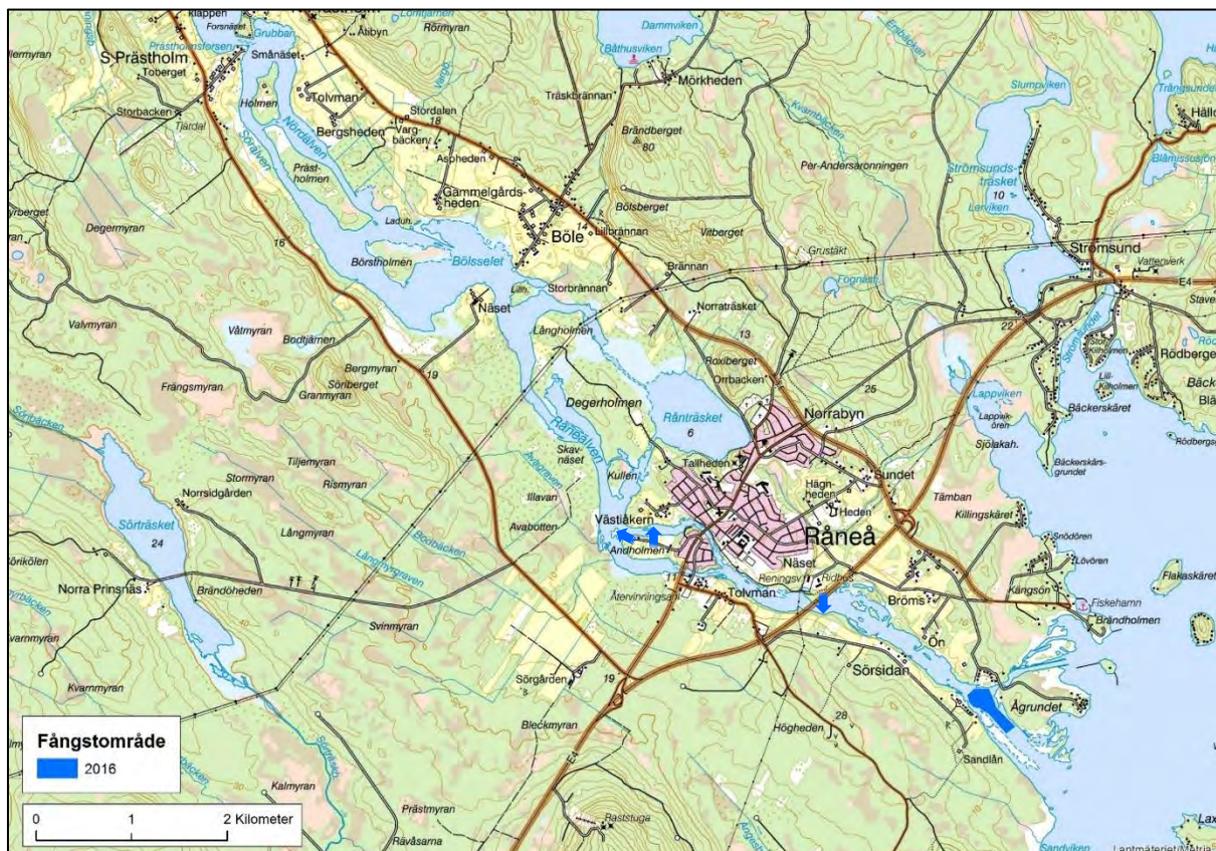
Figure 2.6. Map of the Råneälven river and the positioning of the telemetry study in 2016. Blue arrows show the positions of fixed receivers and the direction of antennae.

In the Råneälven river study in 2016 two stationary receivers were used to log tagged whitefish. One at the E4 bridge and one upstream of the Norrgren rapids. A switch box and two antennae were used at the receiver in Norrgren to increase resolution and detect whether tagged whitefish continued upstream in the river. See Figure 2.6 for the set up and positioning of antennae.

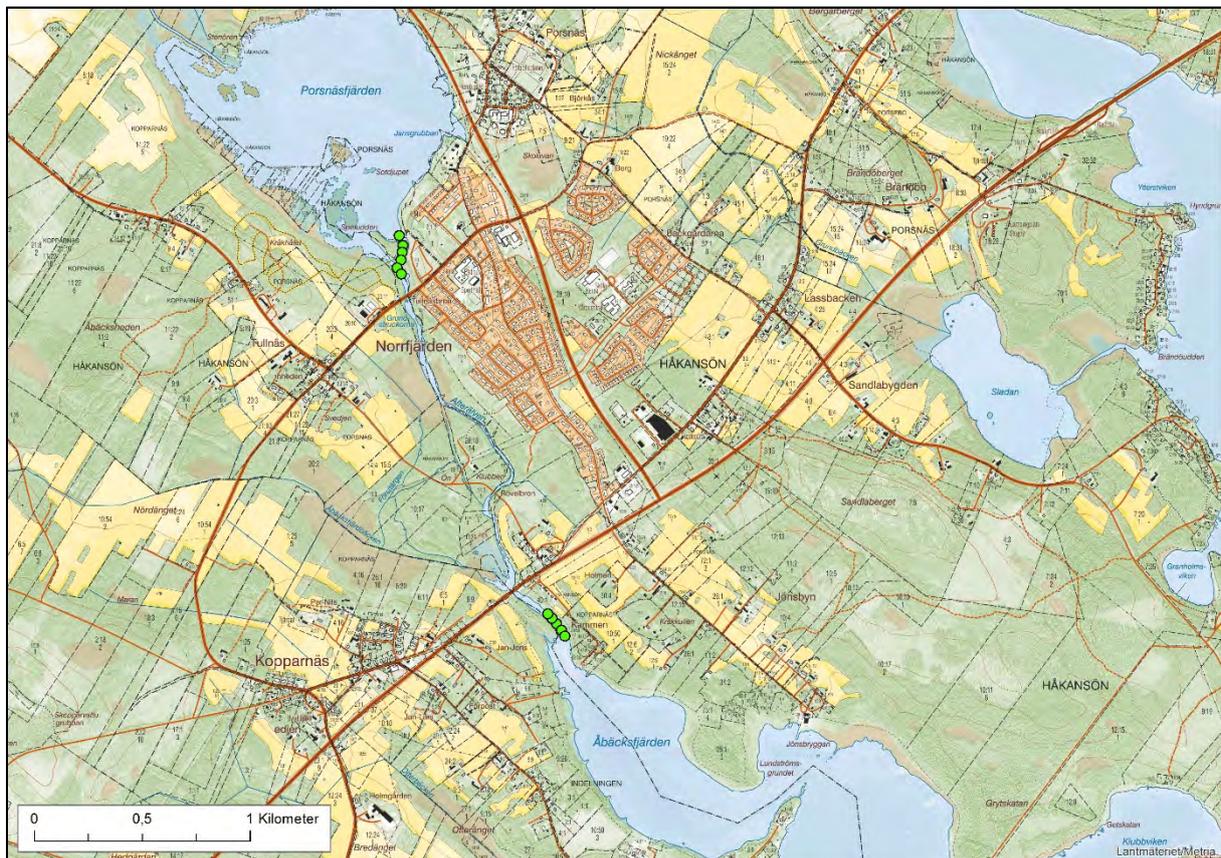
Figure 2.8. Map of locations for egg pumping on 13 November 2017. Sampling points one to five in the downstream area and six to eleven in the upstream area.

The results of egg pumping show that eggs were present in all locations, and that there were more eggs at the spawning ground farthest downstream than upstream (see table). Eggs were also found upstream of the remedied migration barrier in the outlet of the Porsnäs fjärd lake, proving that the whitefish had been able to pass it following the work undertaken.

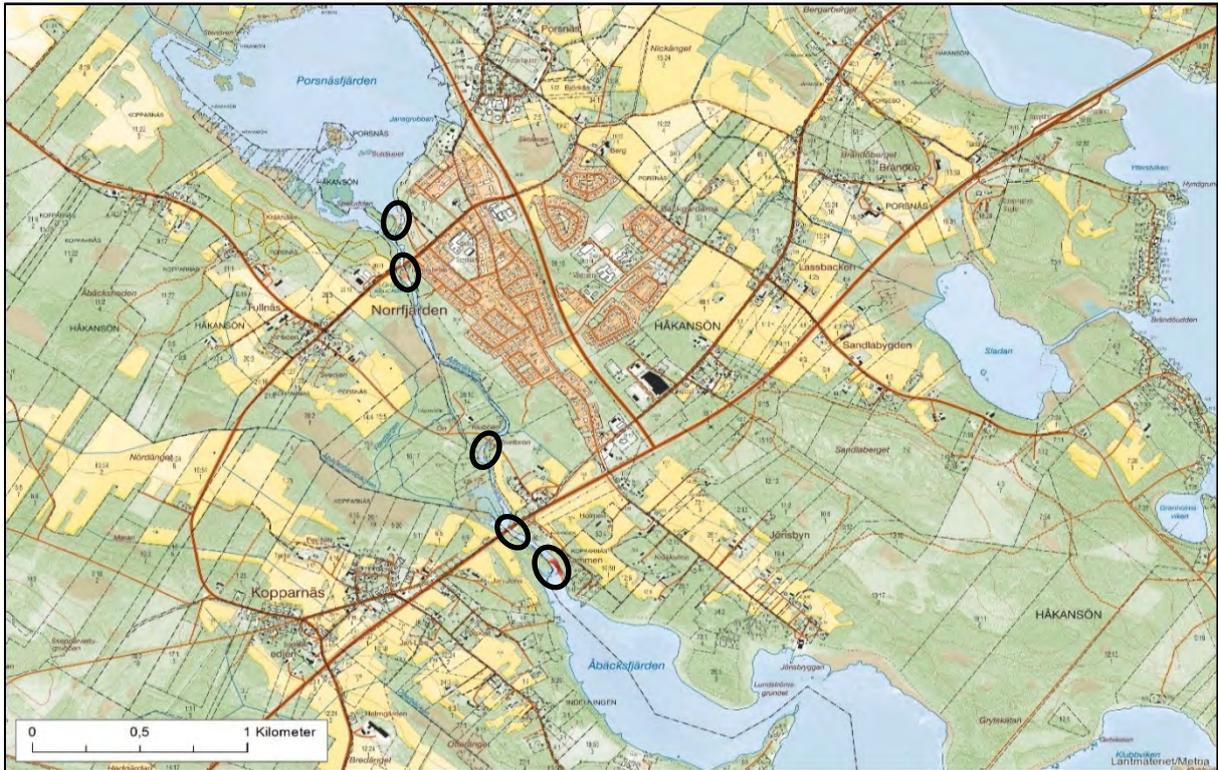
Figure 2.11. Map of the zones used and their scores in the Alterälven river during the 2015 study (the darker the red colour the higher the score). Blue ovals show the spawning grounds identified.

Based on where spawning behaviour was observed (fish chasing each other and splashing on the surface), four main spawning grounds were identified (Figure 2.11). The same areas were also included in the results of GIS analyses of the zones in which the tagged whitefish were found during the period in which spawning behaviour was observed (Figure 2.12). Certain spawning behaviour was also observed outside the identified zones, but always in close proximity to them.

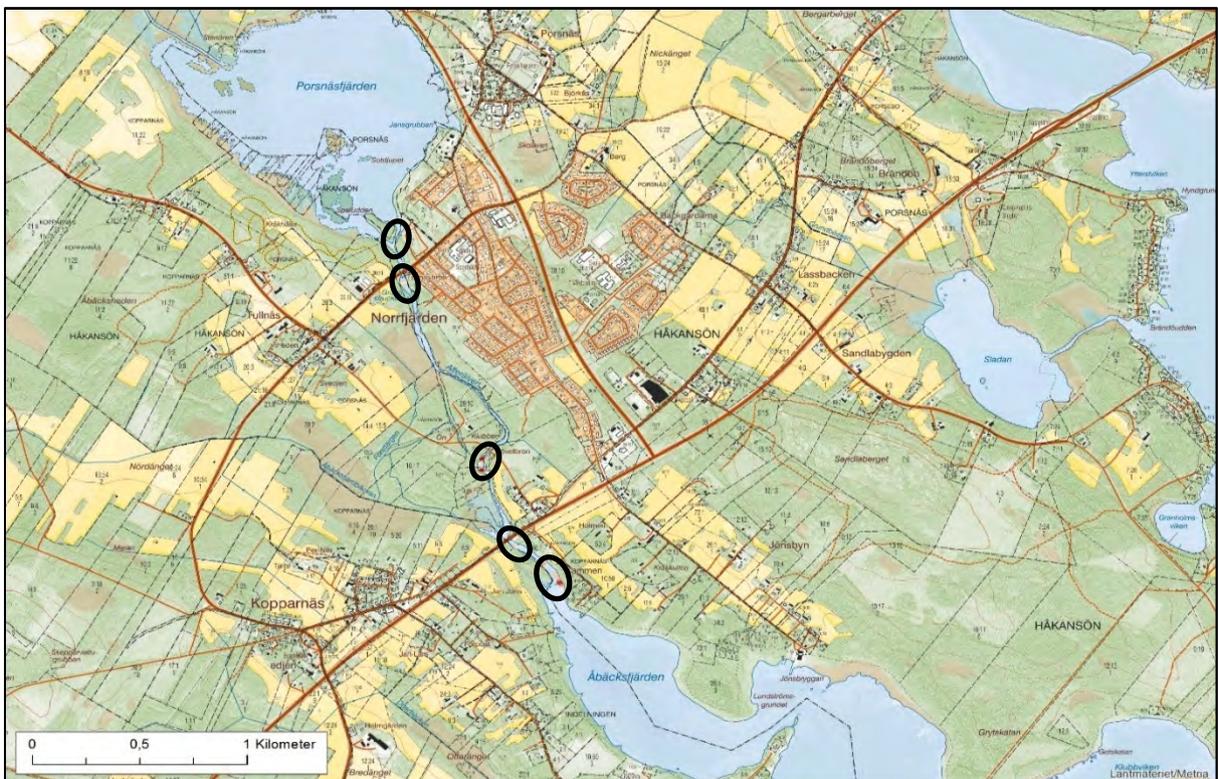
Figure 2.12. Map of the zones used and their scores in the Alterälven river during the 2017 study (the darker the red colour the higher the score).

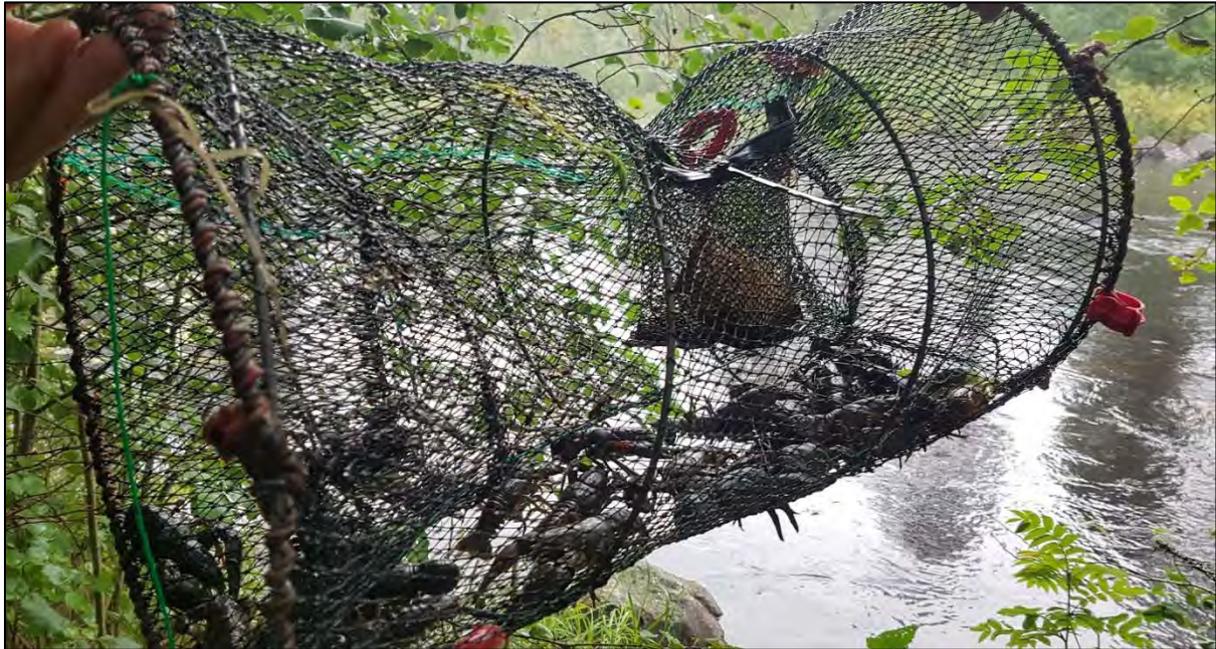
Figure 3.2. Photograph of a crayfish trap being checked in the Alterälven river.

The traps used were a model with two horizontal entrances and two escape openings for small crayfish (Figure 3.2). Exploratory fishing was carried out in each locality using eight crayfish traps baited with pieces of roach and bream. The crayfish traps were set out in the evening between 20:00 and 22:00 and were checked in the morning of the following day between 06:00 and 08:00.

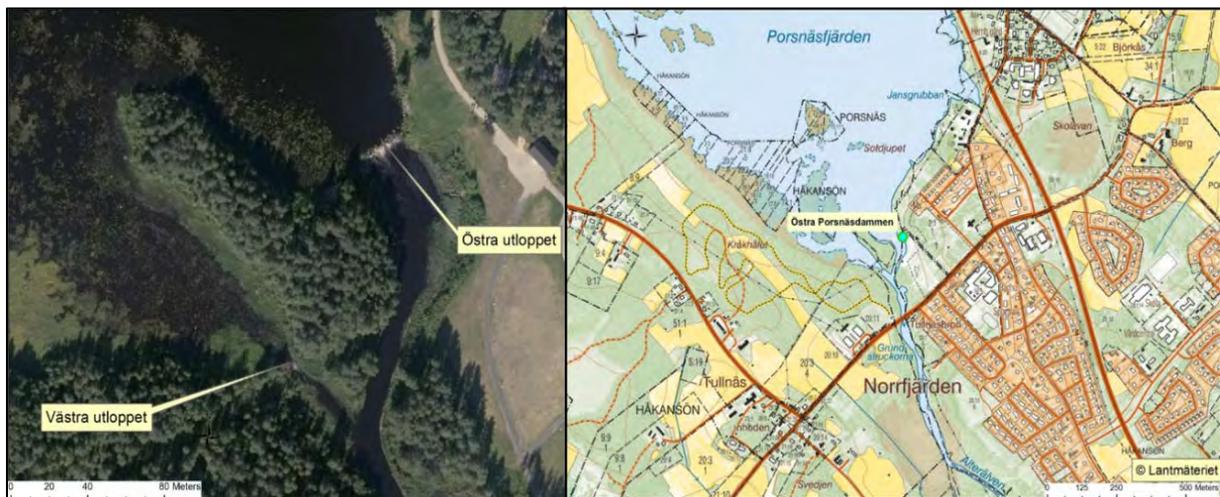
Figure 4.1. Map of the east Porsnäsdammen dam (green dot) and a contemporary aerial photograph.

During the log floating period in the Alterälven river, the Porsnäs fjärd lake was lowered by excavating the outlet (Figure 4.1). At the same time a channel was excavated through the lake, closing off the shallower sections at its northern end. As a result, the lake began to choke with weeds. In connection with restoration work in the 1970's, Piteå municipality constructed the rock weir at the Porsnäs fjärd outlet in order to raise the water level in the lake and restore the earlier water mirror. Unfortunately, the rock weir became a migration barrier to h during the low water discharge that usually occurs during the summer and late autumn. The aim of the planned measure is to allow the free passage of fish and other aquatic fauna through the weir at the outlet of the Porsnäs fjärd lake.

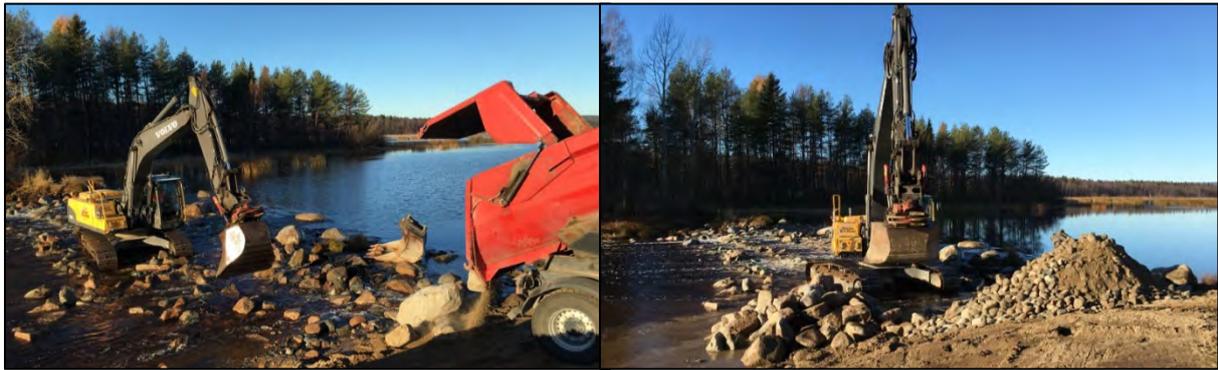
Figure 4.2. Transport and arranging the rock using an excavator.

To create a free migration route at the Porsnäsdammen dam, rocks of mixed sizes were placed out in the area, extending the short weir about fivefold. This measure created a weir with less of a slope and a longer stretch of rapids. The material placed out in the dam was transported by truck from a natural gravel quarry in Kallaxheden. The material consisted of large and medium rocks and smaller stones. The rock was tipped out at the dam and an excavator arranged the material following instructions from the county administrative board (Figure 4.2).

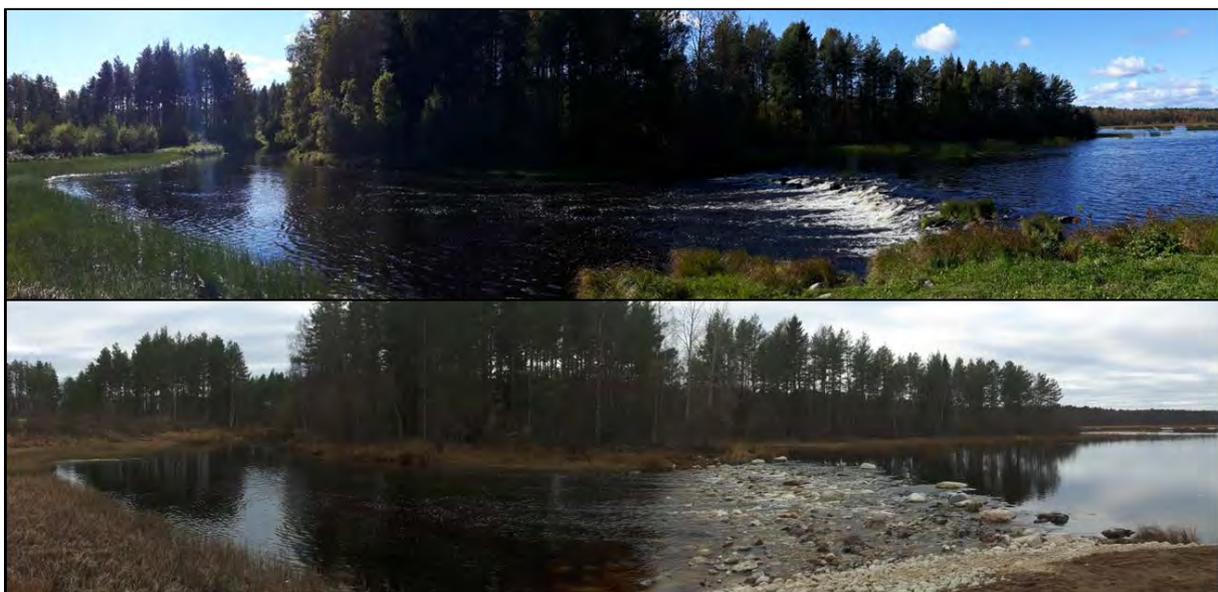
Figure 4.3. Porsnäsdammen before (upper photo) and after (lower photo) remedial work in 2016.

In total approximately 400 m³ of rock was arranged in the weir. In migration studies carried out as part of this project on radio tagged whitefish in 2015 and 2017 in the Alterälven river, no fish passed the weir at the outlet of Porsnäs fjärden lake in 2015, while two tagged whitefish passed the site of the migration barrier in the outlet of the Porsnäs fjärden lake which had been remedied in 2016. These results show that whitefish, and probably other species, can pass the remedied weir when water discharge is low. At high outflows the weir does not constitute a migration barrier for any species.

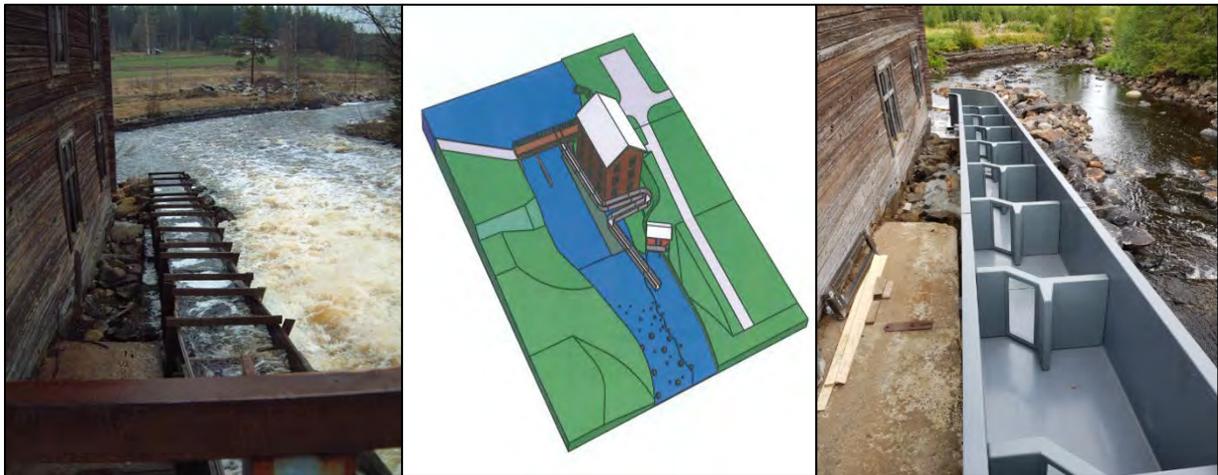
Figure 4.4. The old fishway to the left and the new fishway to the right, manufactured in composite with slot openings 2018.

The remedial work planned is to replace the existing dilapidated fishway with a vertical slot fishway. A design suitable for fish species that are poor swimmers (Figure 4.4). The fishway is of a modular construction in composite material from Composite Service Europe AB in Öjebyn. Slots in the channel control water flow and reduce the energy in the water current. The new fishway has a lower incline

The fishway is manufactured in sections at the factory and assembled on site on poured concrete foundations. The fishway incline is approximately 6% and will follow the route of the old fish ladder with an extra u-bend below the mill to reduce the gradient. The inlet section can be adjusted to accommodate variations in flow with varying amplitude.

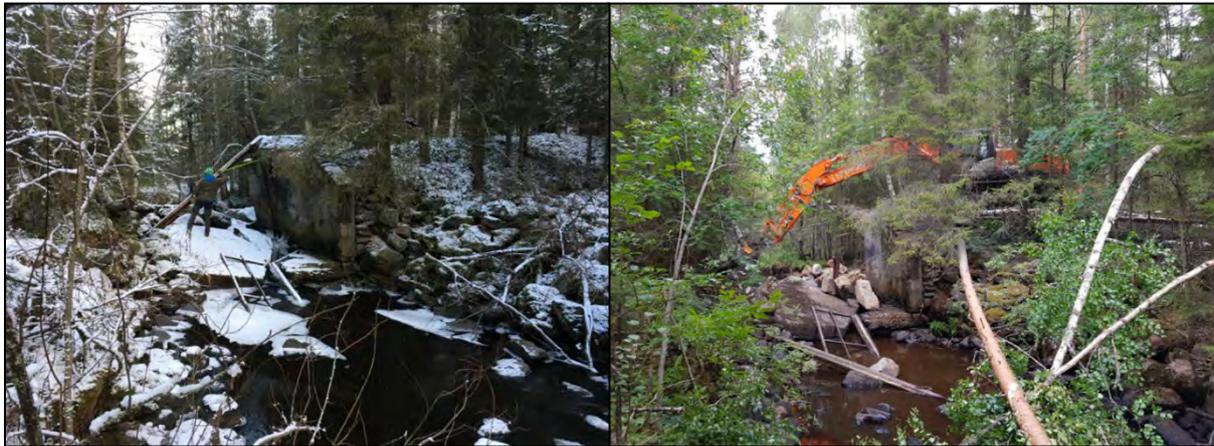
Figure 4.6. Baronseldammen dam in the Rosån river prior to work being undertaken. Concrete and metal structures were removed from the watercourse and from both banks.

The concrete debris that has fallen into the Rosån river and created a migration barrier for fish and aquatic fauna were lifted out. The side structures on either side of the watercourse were also

demolished as they leaned in towards the watercourse and risked falling into the Rosån river, posing a risk to the general public. Structures made of metal that had fallen into the Rosån river were also removed (Figure 4.6).

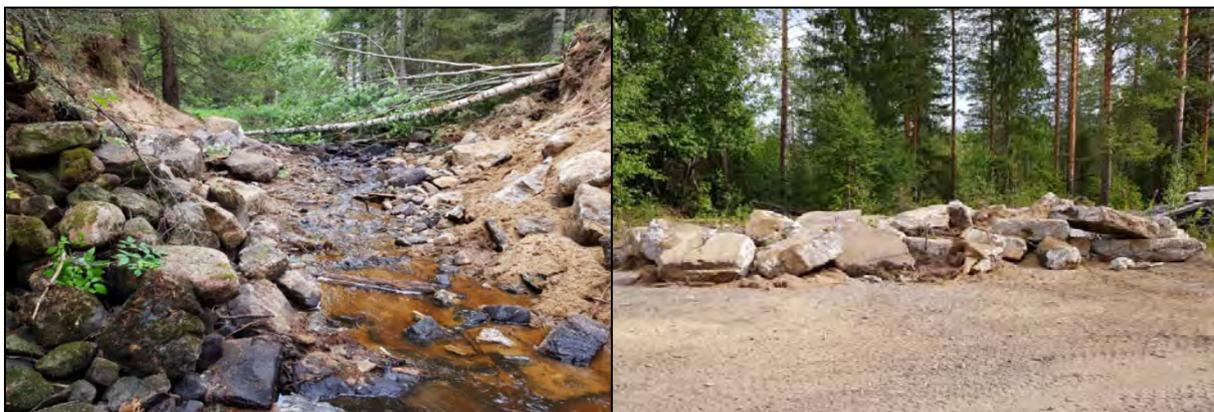
Figure 4.7. Baronseldammen dam, Rosån river after work to create a modified channel for migrating fish. The concrete material on the right was transported to landfill. There was an extremely low water discharge (about 3 litres per second) when the work was carried out.

When the concrete and metal structures that formed a migration barrier for fish had been removed, work was carried out on the stretch of river by the dam to create a free migration route. All concrete and metal structures were transported away from the dam. The contractor was responsible for the recovery and transport of material to landfill (Figure 4.7).

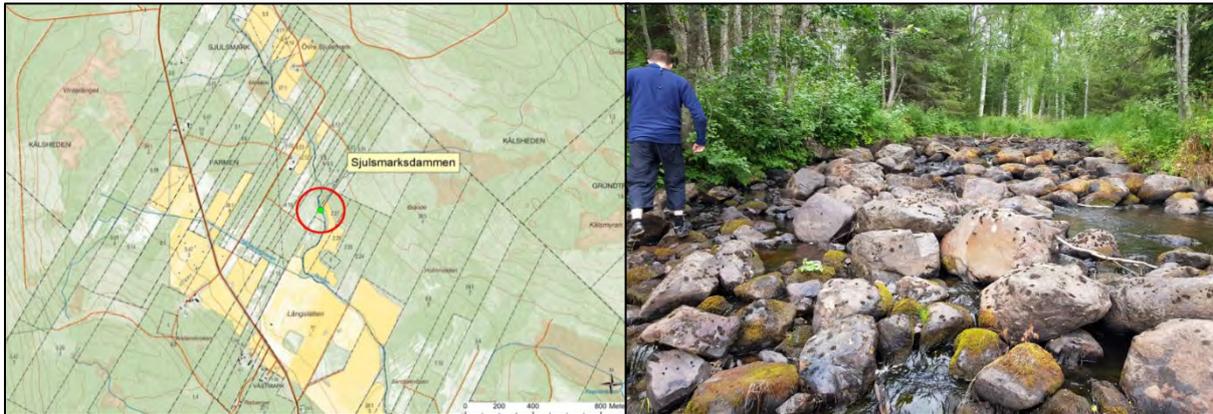
According to information, the dam was demolished some time ago and what remains is an approximately 40 metre long weir of large rocks across the Rosån river. The difference in level between the upper and lower water mirrors is about 1.5 metres. The weir is not considered a definitive migration barrier at high water levels when fish can get past it. However, at low and very low flows, the water runs between the rocks, making it impossible for fish to get past the weir (Figure 4.8).

Figure 4.8. Map and photography (very low water level) with the Sjulsmarksdammen dam (green dot inside the red ring).

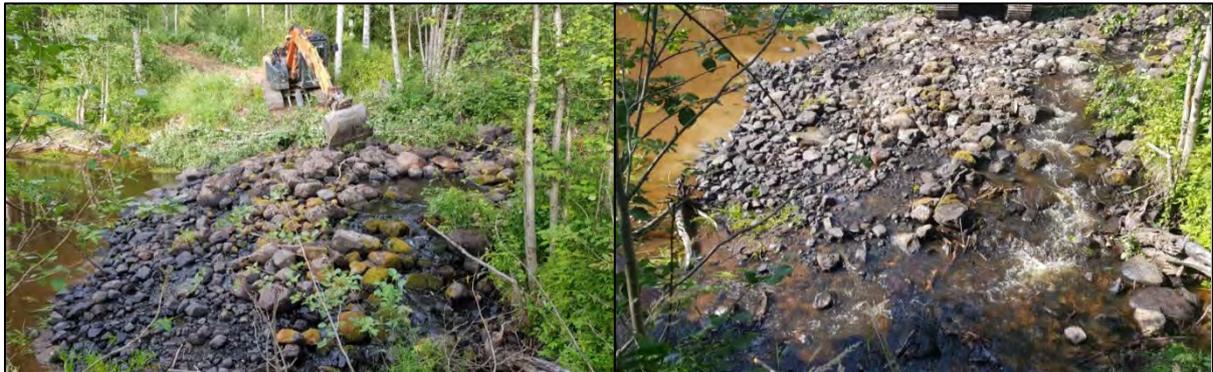
Figure 4.9. The picture on the left shows the weir before work was carried out, and the picture on the right shows the concentrated channel at the bottom of the rock weir. On the day that work was carried out the water flow was about 5 litres/s.

To allow fish and other aquatic fauna to pass, a passage was constructed through the existing rock weir. Boulders were moved using an excavator so that a concentrated channel could be constructed through the rock weir. This channel acts as a passage for fish when water levels are low in the Rosån river (Figure 4.9 and 4.10). When the water discharge is higher the water passes across the entire width of the weir and so does not prevent fish migration.

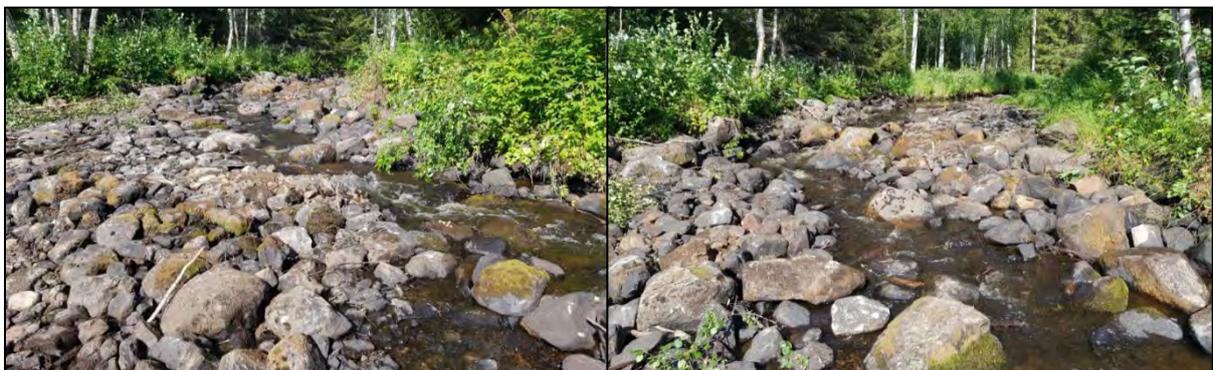
Figure 4.10. The picture on the left shows the middle section of the weir following the work and the picture on the right shows the upper section of the work. On the day that work was carried out the water flow was extremely low, about 5 litres/s.

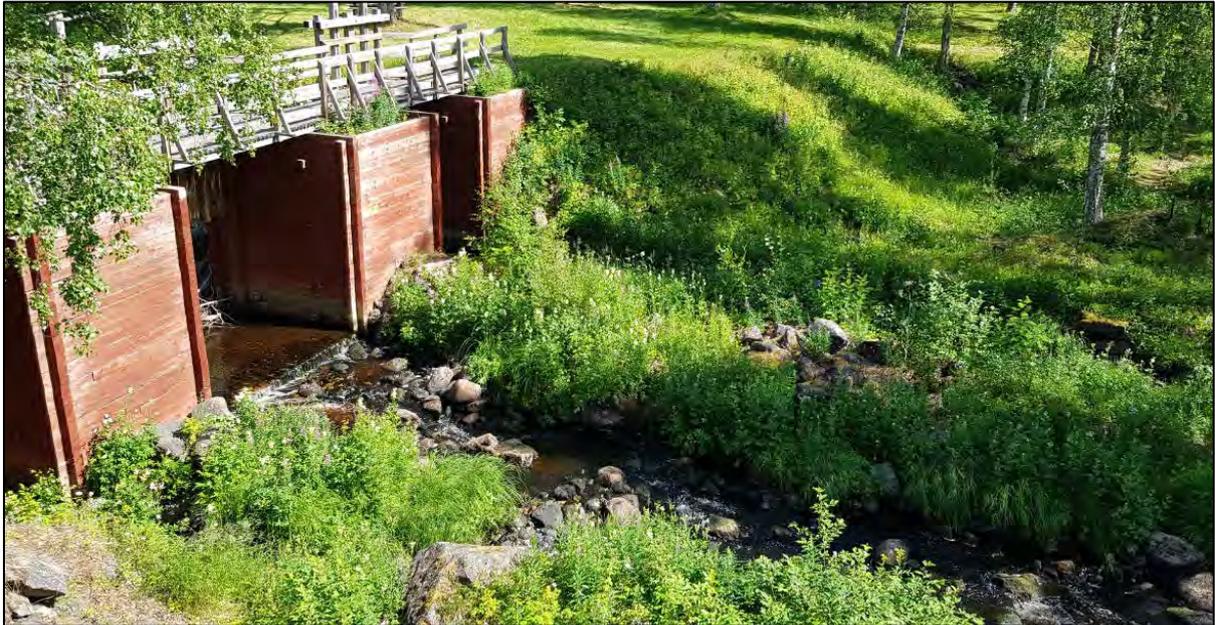
Figure 4.12. Dammen i Rosfors, Rosån innan åtgärd. Extremt låg vattenföring i Rosån.

The planned remedial work at the dam was to add varying sizes of rock to the downstream side of the dam's central spillway. In total, 5 m³ of rock was added downstream of the dam. Due to the area's cultural protection, the work was carried out by hand. To concentrate the flow at very low water discharges, wooden beams were mounted in the floor of the dam, raising the water level and concentrating the outflow. As a result of this the unnatural fall was removed and height of fall was levelled out, allowing the free passage of fish and other aquatic species even at very low water discharges. When the work was carried out the water discharge was very low, about 4 litres/s (Figure 4.12 and 4.13).

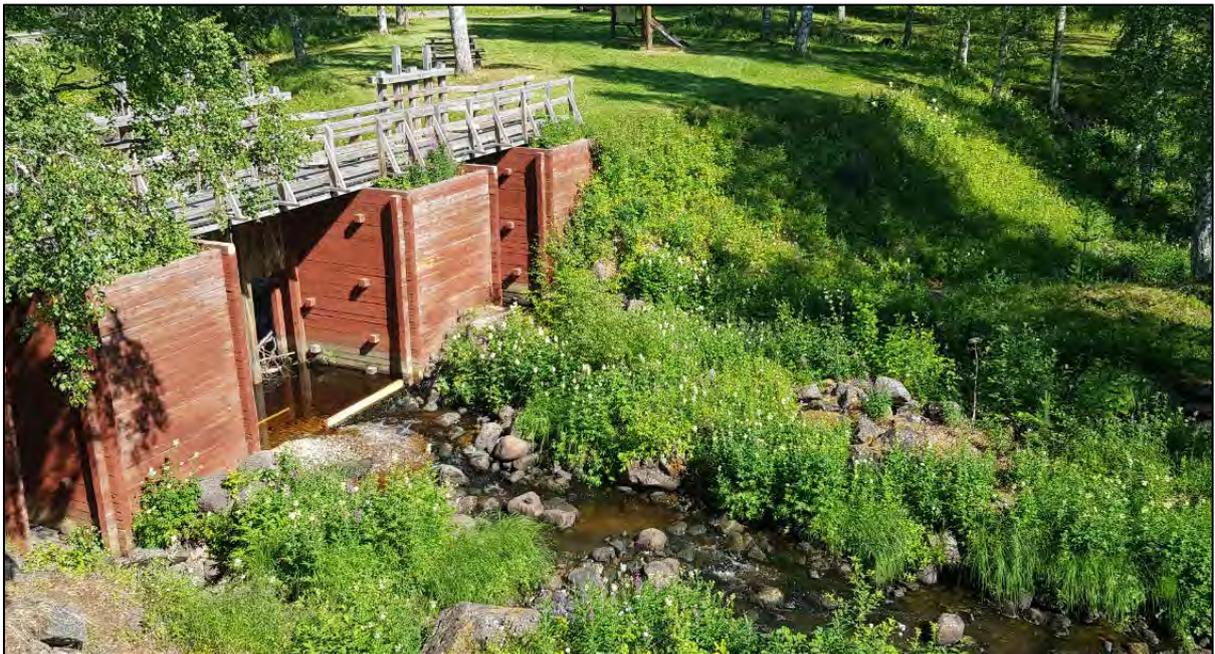
Figure 4.13. Dammen i Rosfors, Rosån efter åtgärd. Extremt låg vattenföring i Rosån.

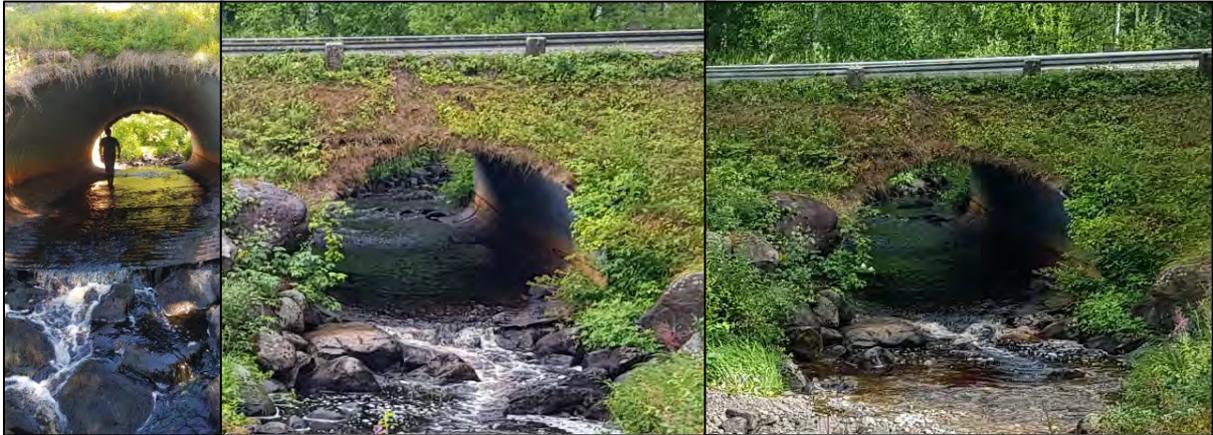
Figure 4.14. Rosfors, road culvert in the Rosån river. The two pictures on the left are before the work was carried out and the picture on the right is after the work was undertaken.

About 50 metres upstream of the dam a road passes over the Rosån river. A sheet metal drum has been laid in the watercourse to allow the road to pass. The road culvert is too level which means that fish cannot pass the fall on the downstream side when the water discharge is low in the Rosån river. By adding rocks of varying sizes, the fall height was evened out and the unnatural fall was reduced (Figure 4.14). When the work was carried out inflow was extremely low which meant that the Rosån river had an extremely low water discharge. When the water discharge is extremely low there are several locations in the Rosån river at Rosforsbruk, besides the dam and the road culvert, which become migration barriers to fish. In total, 30 m³ rock was deposited downstream of the road culvert using an excavator, the work took a day to carry out.

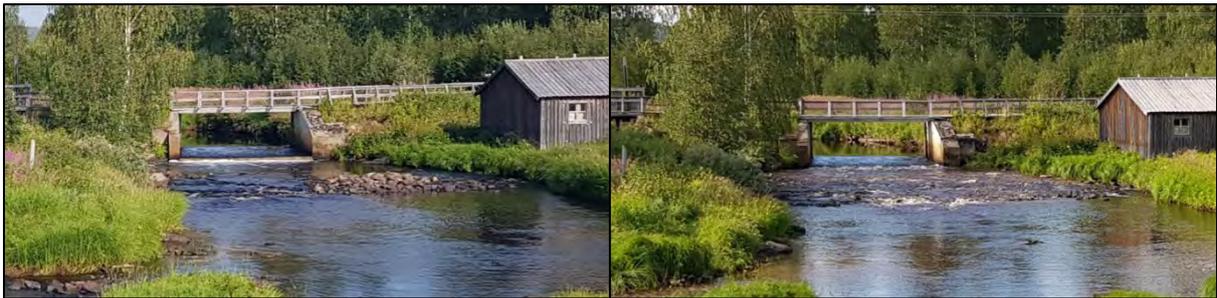
Most of the water flows through the middle spillway in the dam structure; this is where the flow of water is concentrated and where the flow rate increases over the gently sloping dam floor. On the downstream side of the spillway a fall forms towards the bottom of the watercourse. This means that fish and aquatic species cannot pass upstream, particularly when the water discharge is low, the site was therefore considered a migration barrier (Figure 4.16).

Figure 4.16. The Alån river with Ale Kvarn at an extremely low water discharge. Before work was carried out on the left and after work was carried out on the right.

Because the dam and its associated buildings are considered to have a conservation value from a cultural heritage standpoint, the work was planned taking this into consideration. In total approximately 120 m³ boulders and rocks were transported and arranged in the area below the body of the dam (Figure 4.17).

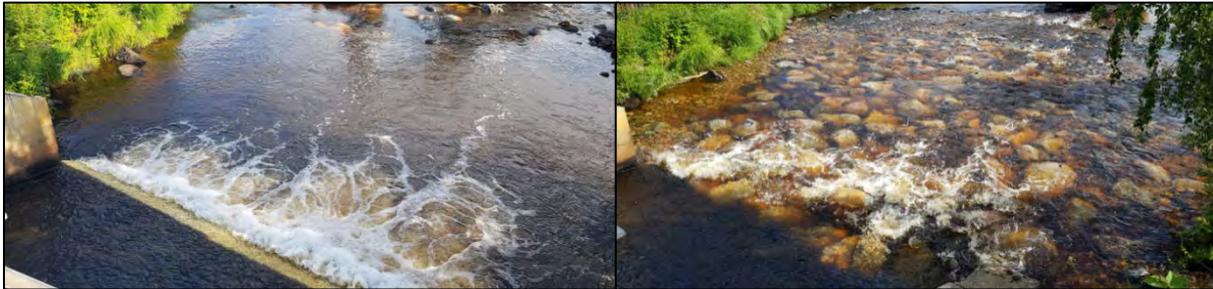
Figure 4.18. The weir at Ale Kvarn in the Alån river before work was carried on the left, and after work was carried out on the right. The water level was very low when the work was carried out.

The arrangement of boulders downstream of the dam meant that the water level there was raised; creating free passage for fish (Figure 4.18). Immediately work arranging the rock was finished five perch were observed moving upstream past the dam. Later fish were observed passing the floor of the sluice upstream.

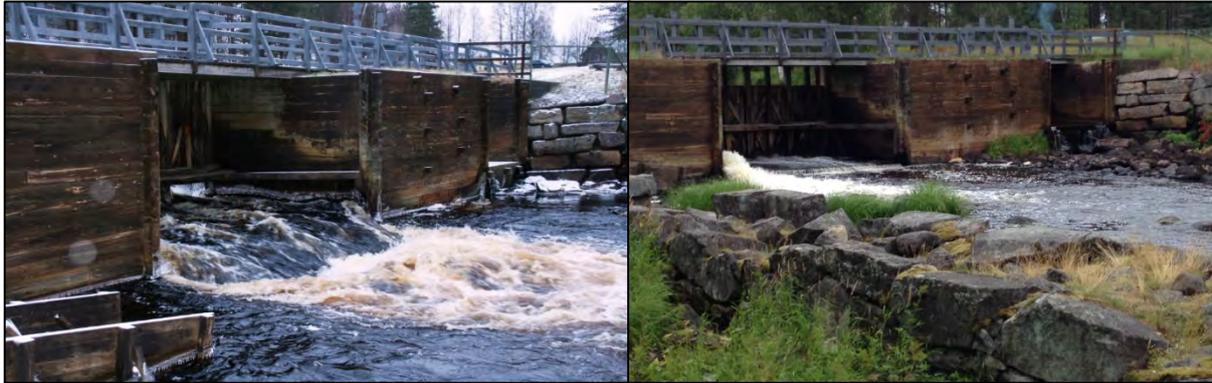
Figure 4.20. The dam construction at Selets Bruk, Alån river. The picture on the left shows the gates open and the picture on the right shows them closed.

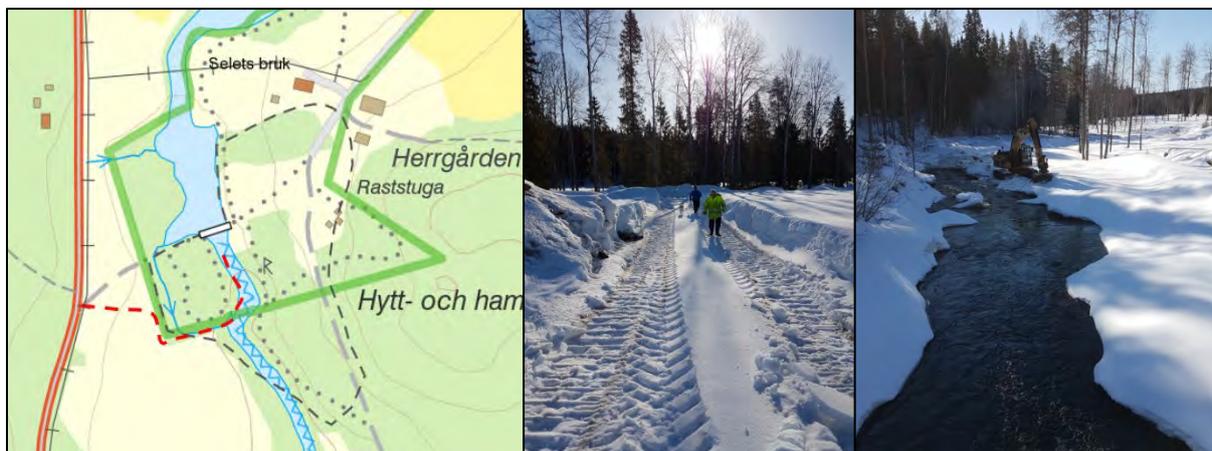
Figure 4.21. Map of Selets Bruk in the Alån river with the winter road (for the excavator and dumper truck) marked (dashed red line) and pictures of the winter road.

The work at Selets Bruk was carried out at the end of April 2018 by building a winter road in March to reduce soil damage and so as to be able to drive an excavator and dumper truck outside the nature reserve and also in the side channel to the left of the main channel of the Alån river. The choice of dates for work also meant that no cultural artefacts were affected.
