Coastal watercourses

Methodological Development and Restoration

Title: Coastal watercourses - Methodological
Development and Restoration

Publication No: 6/2019

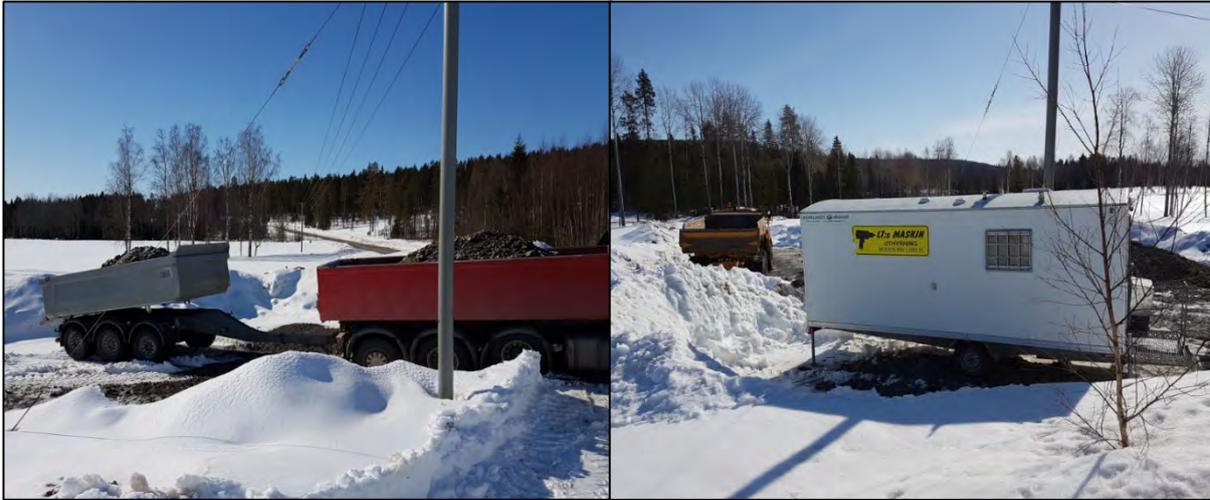
Figure 4.22. Transporting material for reloading onto a dumper truck (picture on the right).

A total of 170 m³ boulders and rock was transported to the site on public roads. From there the material was reloaded onto a dumper truck that transported the material on the winter road down to the main channel of the Alån river, about 20 meters upstream of the outflow of the side channel (on the right bank viewed from above) to the main channel (Figure 4.22).

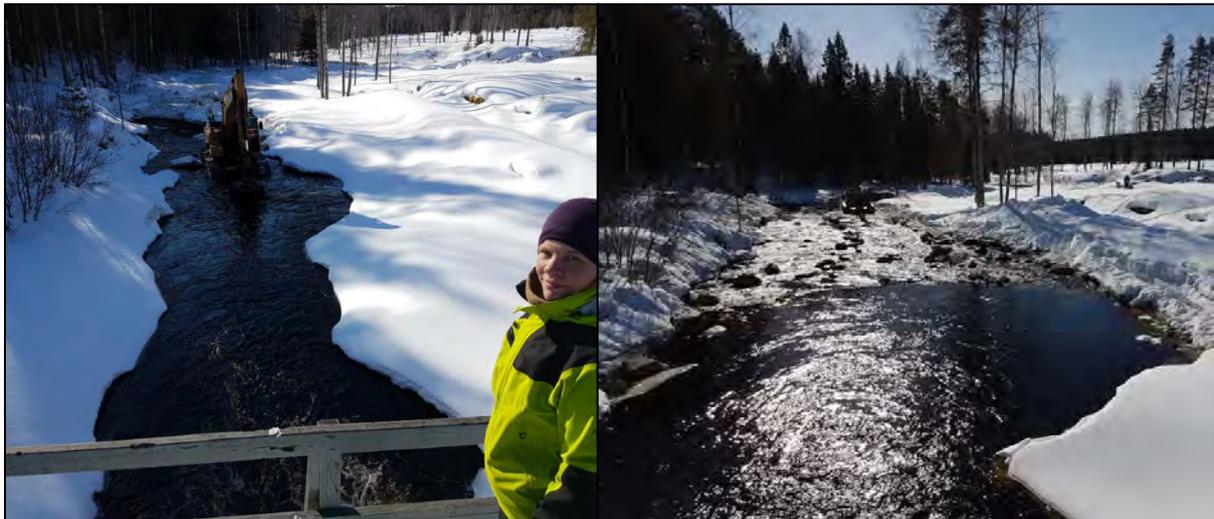
Figure 4.23. The picture on the left shows the transport of material by an excavator into the main channel of the Alån river, and the picture on the right shows the arrangement of rock in the works area.

From the dumper truck's unloading site in the main channel of the Alån river, the material is lifted up by the excavator to the works area (Figure 4.23).

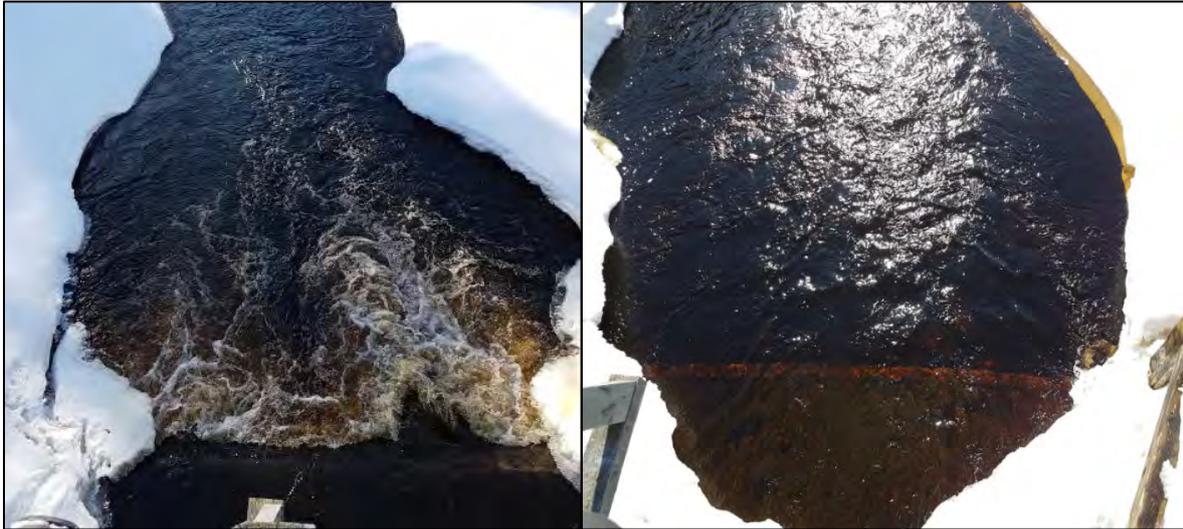
Figure 4.24. The picture on the left is before work was carried out and on the right after work was carried out at Selets Bruk, Alån river. After the work was carried out the water level below the dam was raised, creating a free migration route for fish (picture on the right).

The rock raised the water level closest to the dam by about 30 cm, creating a free migration route for fish through the opening of the middle gate, even when the water flow was low in late winter when the work was undertaken (Figure 4.24).

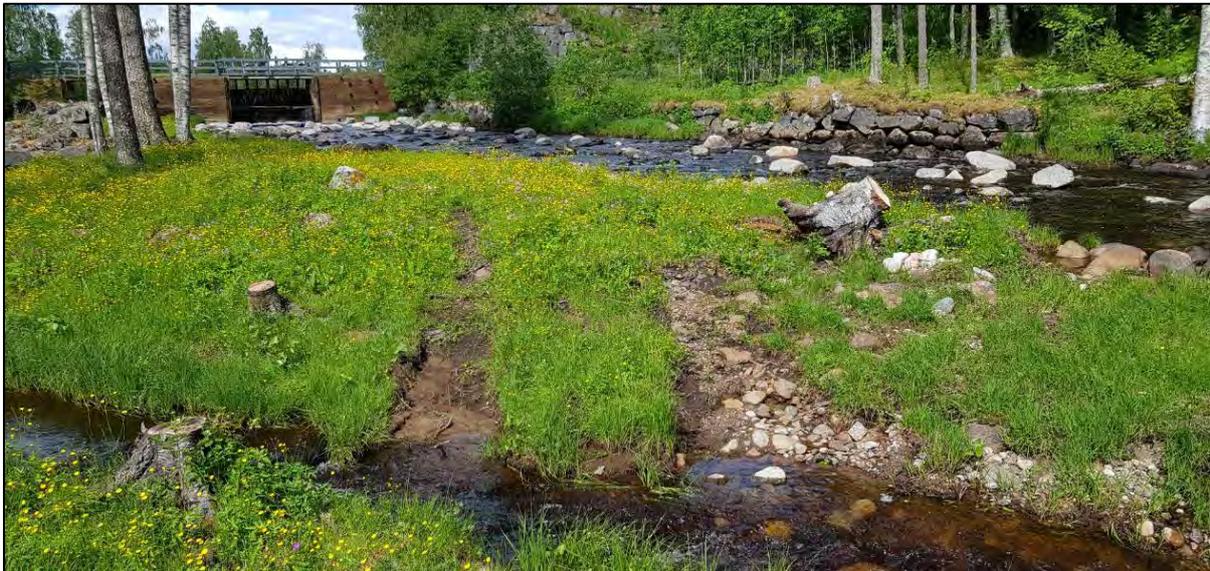
Figure 4.25. Transport route for the excavator and dumper truck at Selets Bruk showing little rutting after the work carried out in April 2018.

Because the work was carried out in April on snow covered and frozen ground, rutting was barely visible where the excavator and dumper truck had driven (Figure 4.25 and 4.26). No trees needed felling for the work. The tree stumps visible in the pictures were felled for conservation in the past. No cultural heritage objects (such as shaped rock) were disturbed because the transport of material was carried out outside the nature reserve and on the frozen side channel on the right (viewed from downstream) and in the main channel of the Alån river.

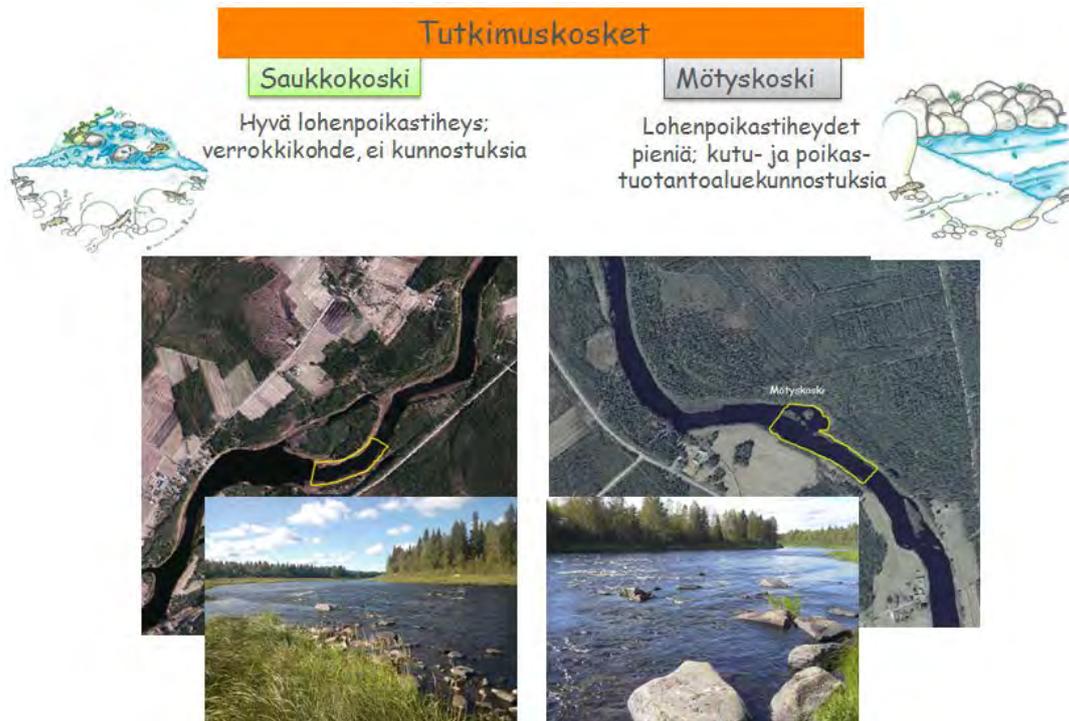
Figure 5. Habitat-modelled rapids of the Simojoki River.

The middle rapids section of Mötyskoski, the average width of which is 40 m in the upper section of the rapids and nearly 100m in the lower section, was selected as the modelling area for Mötyskoski. The lower section contains a cove of the river that widens the surface area of the water (Figure 5).

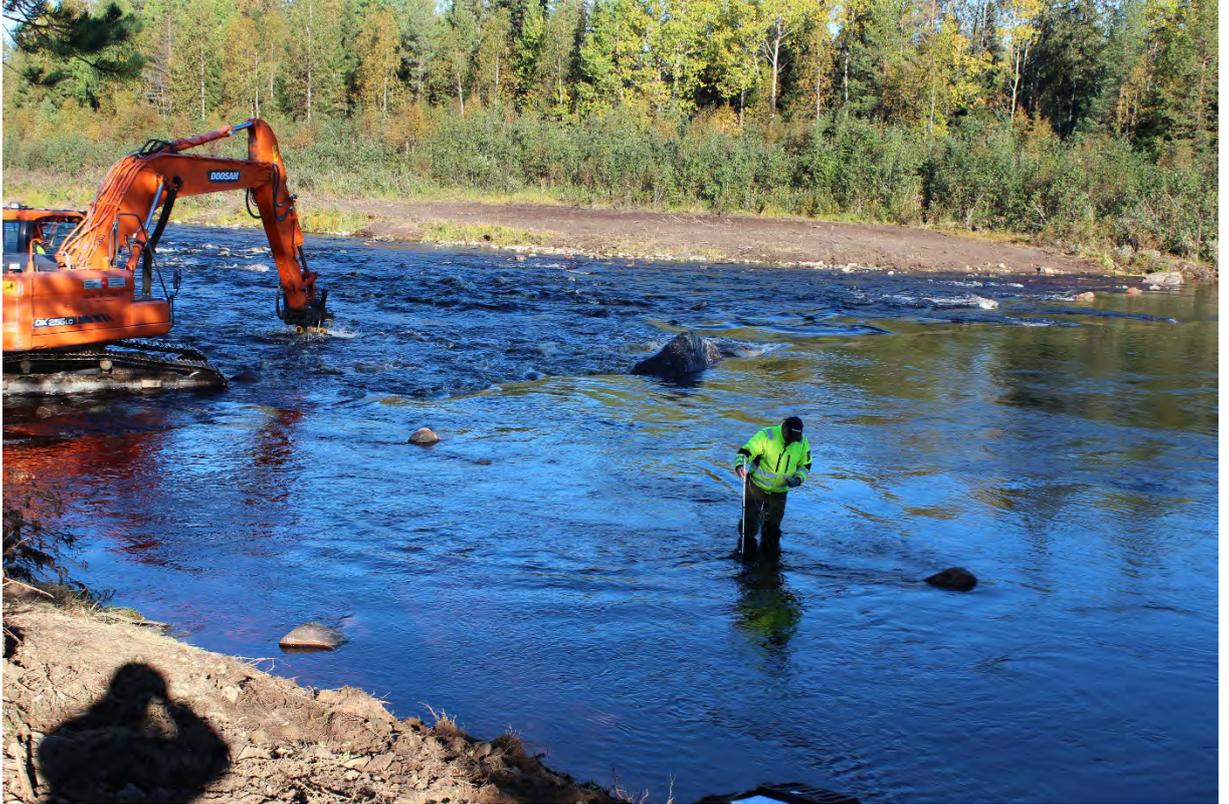
Figure 1. Water current speed and riverbed depth are measured in connection with the restoration work.

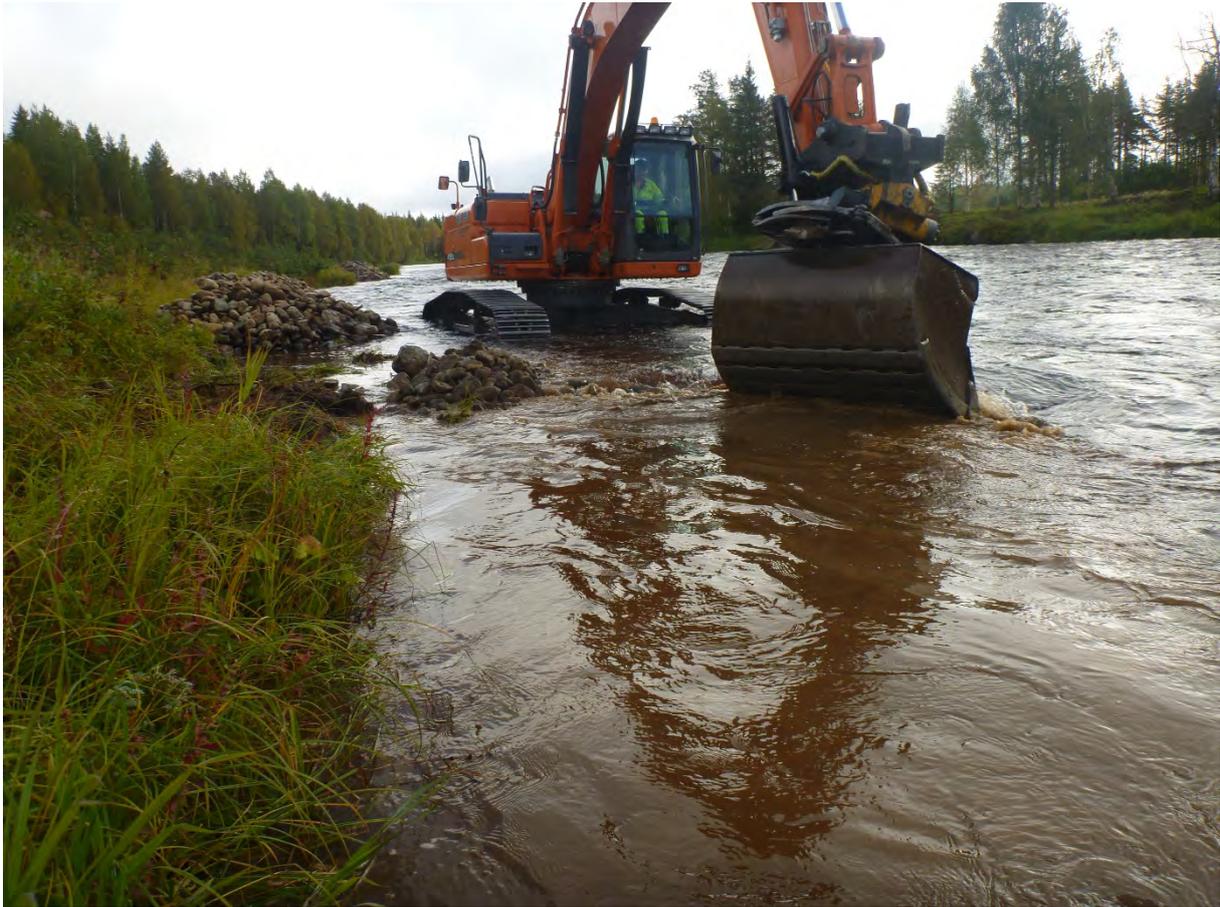
Figure 2. Stone material ready to be used for making a rocky salmon-fry area at Mötyskoski.

Mötyskoski was approx. 4,500 m². Over the course of restoration, this area increased by just over 10% to 5000 m². The most labour-intensive restoration work in the project occurred in the middle and lower rapids sections of Mötyskoski. About 690 tonnes of sifted spawning gravel (grain size of Ø 20–100 mm), 370 tonnes of stones for fry (grain size Ø 100- 200 mm), and 200 tonnes of bed stones intended for the river bottom in the fry area (grain size Ø 200-500 mm) were brought to the aforementioned restoration sites. In the middle section of the rapids, the spawning areas were constructed near the edges of the riverbed. The decision to do this was compelled by the conditions that prevailed during the summer of 2016. As an extension of the spawning areas, so-called small-fry areas, intended to be easy for salmon hatchlings to reach, were constructed. In the middle section of the Mötyskoski rapids, a total of 7 spawning areas were constructed, 4 of them located on the right edge of the riverbed, and 3 of them on the left edge, beside the thresholds constructed at the rapids. The depth of the riverbed in the spawning area varied between 40 -150 cm, and the thresholds were constructed so that water depth would increase towards the central riverbed. The speed of the current in the spawning areas varied between 0.5 - 0.8 m/s. A large difference between the discharge rates in summer 2016 and 2017 was caused by the fact that the plan for reshaping the riverbed, and the consequent discharge rates, ended up being changed in summer 2017 in such a way as to ensure that the current and its speed in the restored spawning areas would be adequate even during the time of the lowest discharge. A total of 5 threshold structures were either constructed or partly reinforced in the middle section of the Mötyskoski rapids. The threshold structures made for the riverbed were aimed at keeping the riverbed wet across the whole breadth thereof, and to create variation and twists in the flow of water through the riverbed. The needed stone material was obtained from the small jetty that had previously been established at the right edge of the riverbed. About 250 m downstream from the upstream start of the middle section of the rapids, the riverbed broadens to a width of almost 100 m. At around this point, older small jetties were demolished, and fry areas with an area totalling about 1,500 m² were constructed using the stone material obtained from the demolished jetties. Jetties that had trees or extensive shrub growth on them were not demolished. The threshold crossing the riverbed in the lower rapids section was reinforced, and a salmon spawning area was constructed upstream from this threshold. The upstream starting area of the lowest rapids section of this fluvial area was reinforced, and the spawning area running across the riverbed in this area was restored. Immediately downstream from the spawning area, small-fry areas, which deepened in the direction of the central

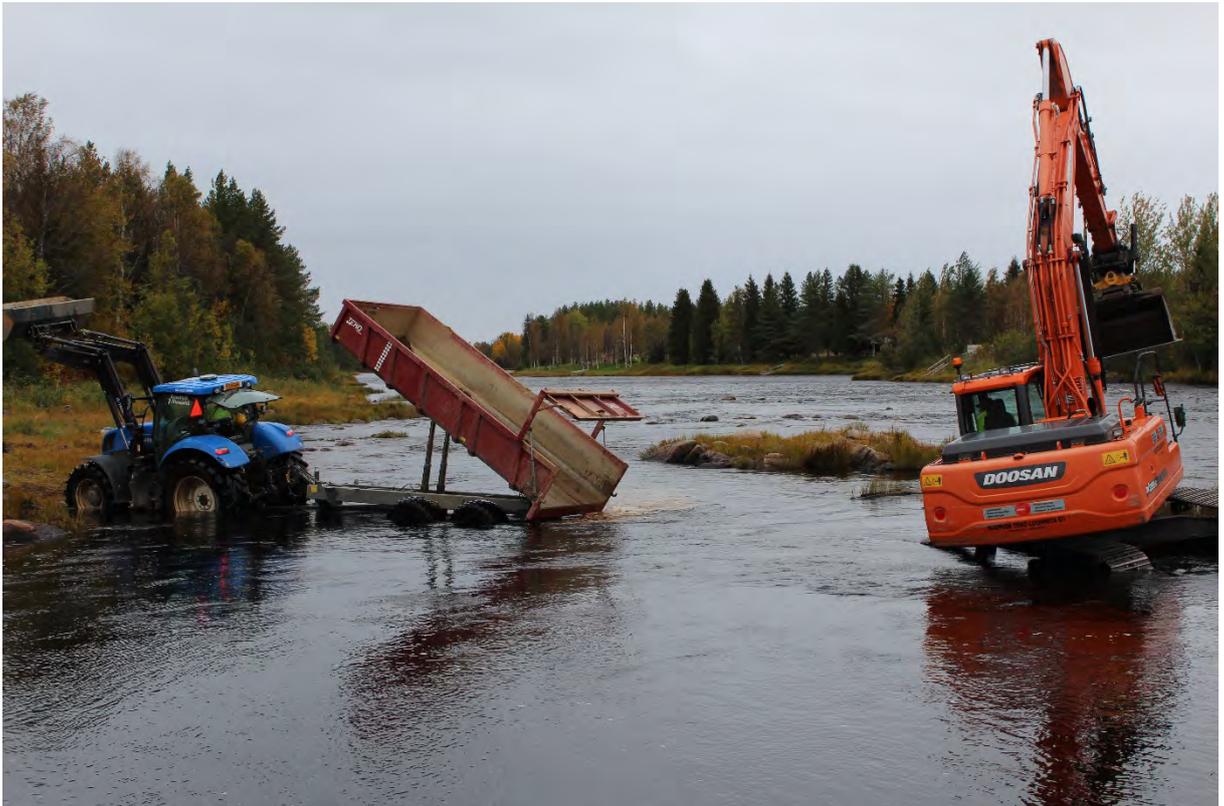
Figure 3. Restoration of spawning area at Kalmakoski - 2016

Restoration work at Kalmakoski was hampered by the high discharge rate of the river during the summer of 2016. Salmon reproduction areas were created at the left edge of the upstream starting area of the lower rapids section. The small jetty that had been on the left side of the riverbed was demolished, and in its place, an area suitable for small fry was constructed. The restored fry area was shaped in such a way that it deepened in the direction of the right side of the riverbed.

In all, about 720 m² of salmon spawning- and small-fry areas were restored at Kalmakoski. About 90 tonnes of sifted natural gravel were brought to Kalmakoski for the purposes of spawning area restoration. Restoration work on the Simojoki for 2016 ended at Kalmakoski on 14/9/2016.

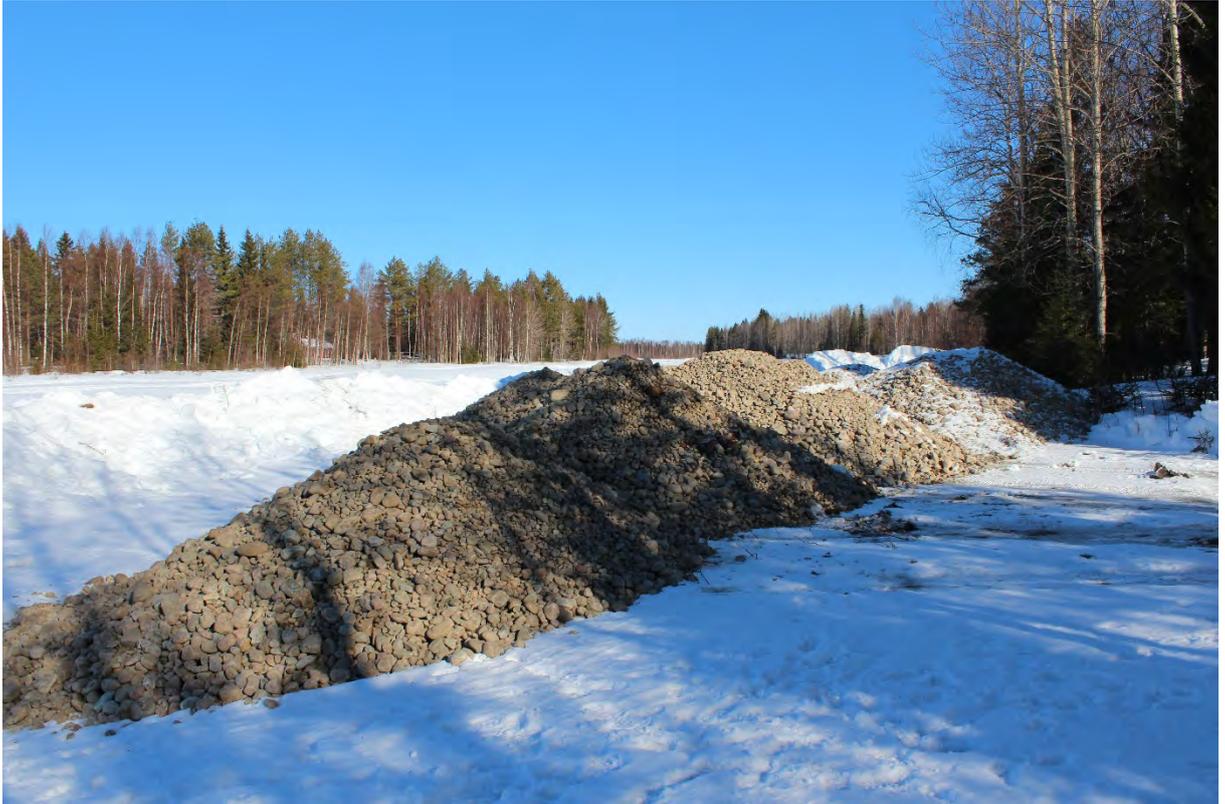
Figure 4. Spawning gravel transported to the riverbank, near the restoration areas, in March-April 2017

Preparations were made for the summer 2017 work by bringing the needed spawning gravel to the vicinity of the restoration areas in late March - early April 2017. At that time of year, the hard, frozen ground / roadbeds are better able to bear the weight of heavy vehicles, thereby reducing potential damage to roads from vehicle movement. Spawning gravel was driven to two different riverbank locations from which it could be easily transported to the restoration sites. The spawning gravel was transported along the riverbed to the restoration sites with a Ponsse Vincent forest machine containing a built-in gravel-transport bed with a tipper.

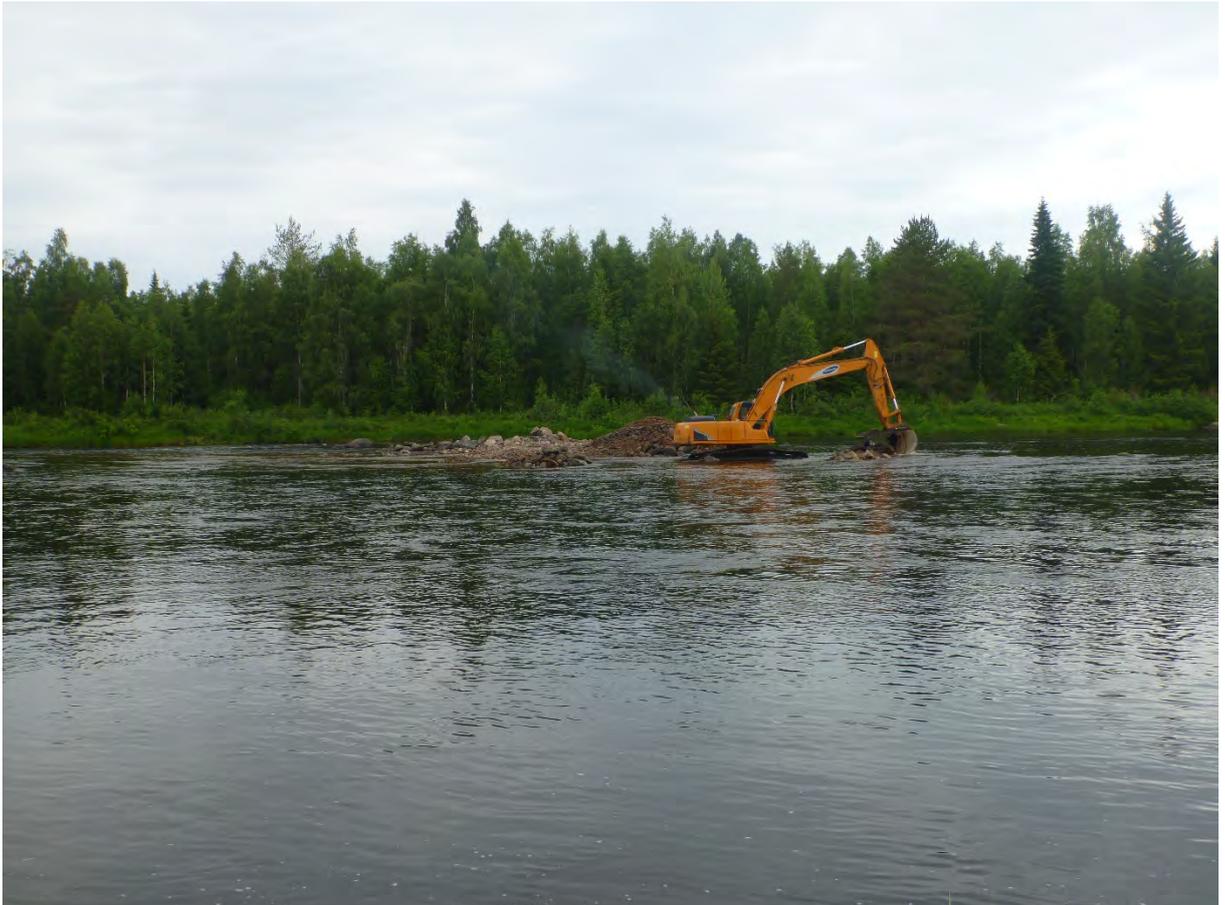
Figure 5. Sifting of stone material in connection with the demolition of the small jetty at Maitokalliovirta.

About 8,000 m² of spawning- and fry areas were restored at Maitokalliovirta. About 700 tonnes of stone material from the demolished jetty structure were sifted and utilised in the restoration work.

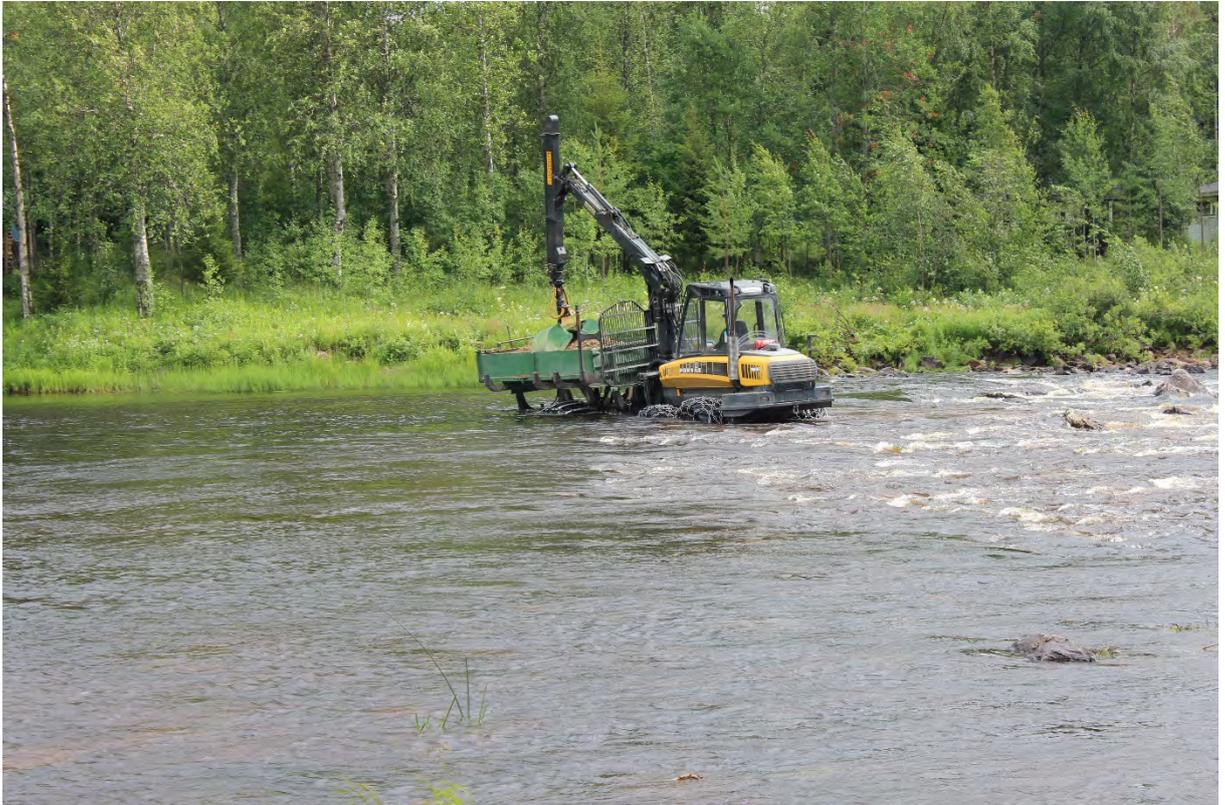
Figure 6. Transport of spawning gravel to the restoration site at Harskukoski rapids, 2017.

A total of seven (7) separate spawning areas were restored at the Harskukoski rapids. The spawning areas were situated near the threshold structures in the rapids, on the upstream side. Small-fry areas were restored immediately downstream from the spawning areas. The threshold structures made for the riverbed were aimed at keeping the riverbed wet across the whole breadth thereof, and to create variation and twists in the flow of water through the riverbed.

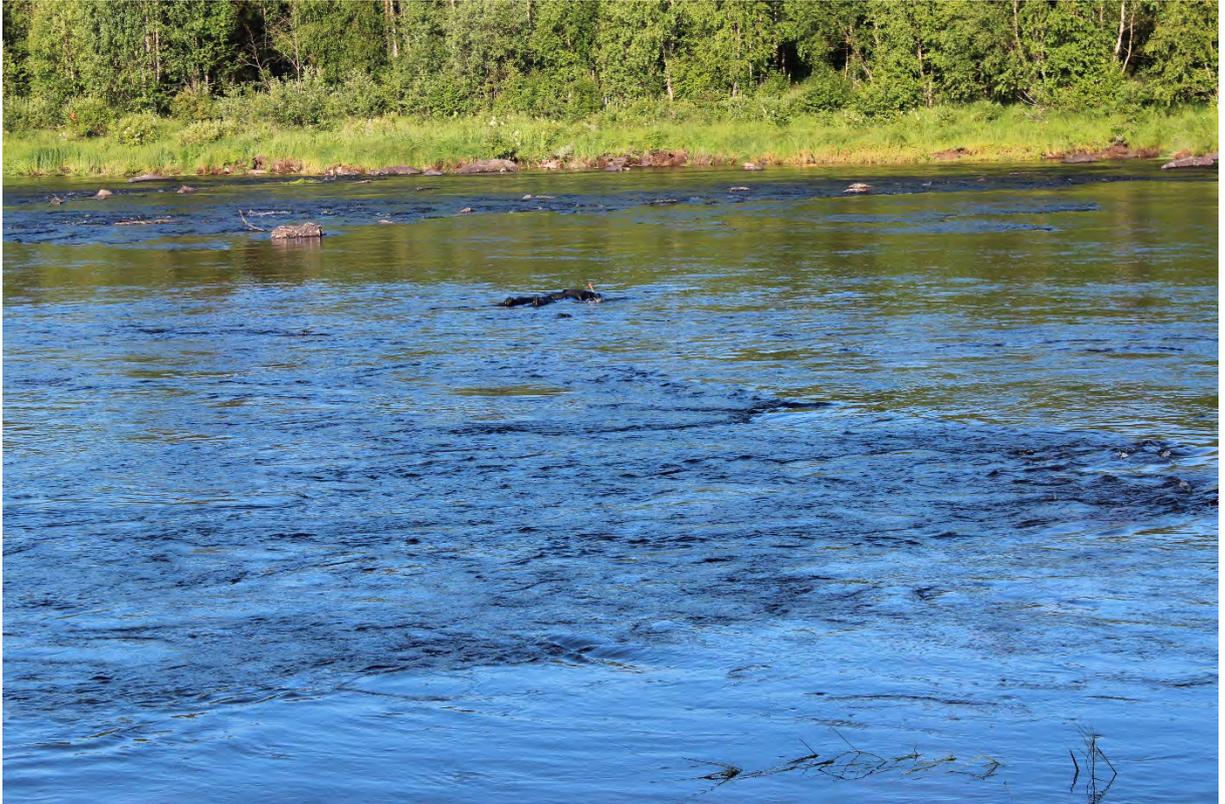
Figure 7. Inspection of the restored spawning area at Harskukoski, 2017.

In all, about 1.5 hectares of salmon spawning- and fry areas were restored at Harskukoski. 340 tonnes of sifted natural gravel were brought to Harskukoski. About 800 tonnes of gravel and other stone material taken from the jetties were sifted and utilised in the restoration work.

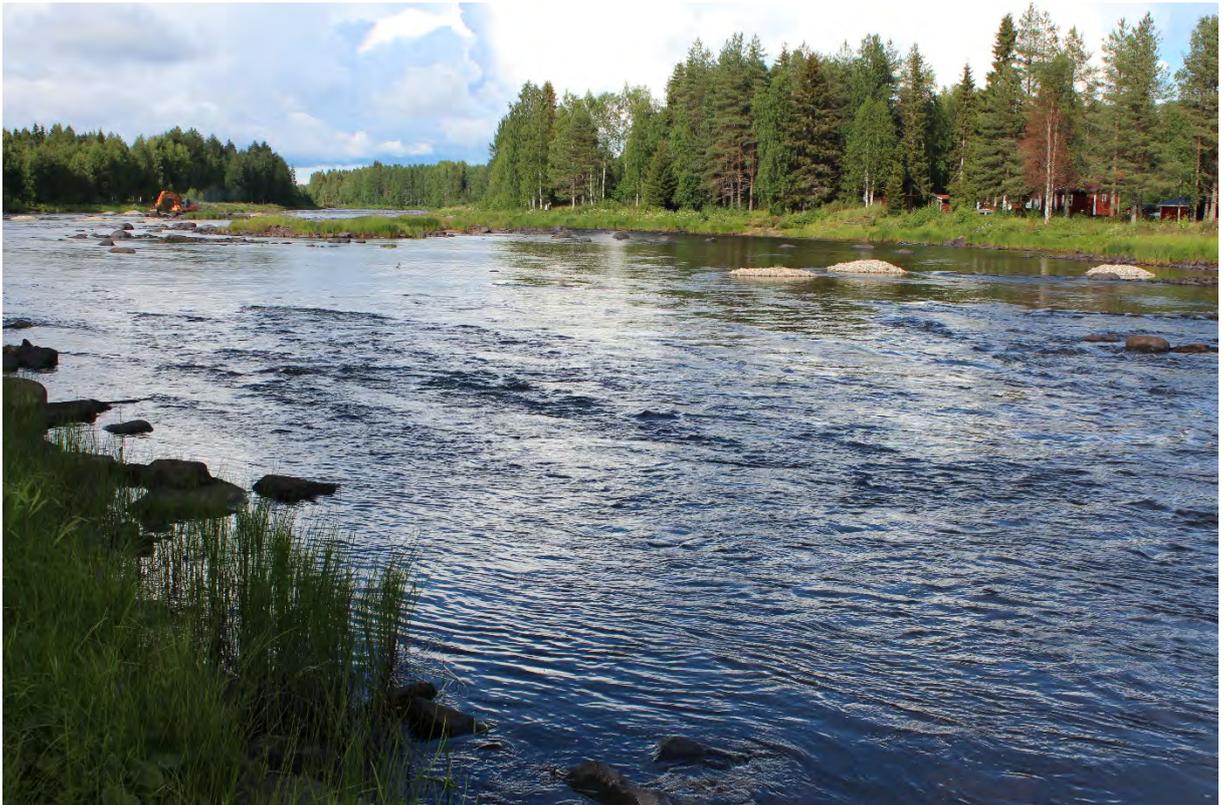
Figure 8. Stone material ready to be used for spawning-area restoration at Kuolemankoski.

A total of 5,500 m of spawning- and small-fry areas was restored in the upstream starting area of Kuolemankoski. About 1,200 tonnes of gravel and other stone material taken from the jetties located at the upstream starting point of the rapids underwent sifting. The aforementioned gravel and stone material was utilised in e.g. restoration of spawning- and small-fry areas. 160 tonnes of sifted natural gravel were brought to the upstream starting area of Kuolemankoski.

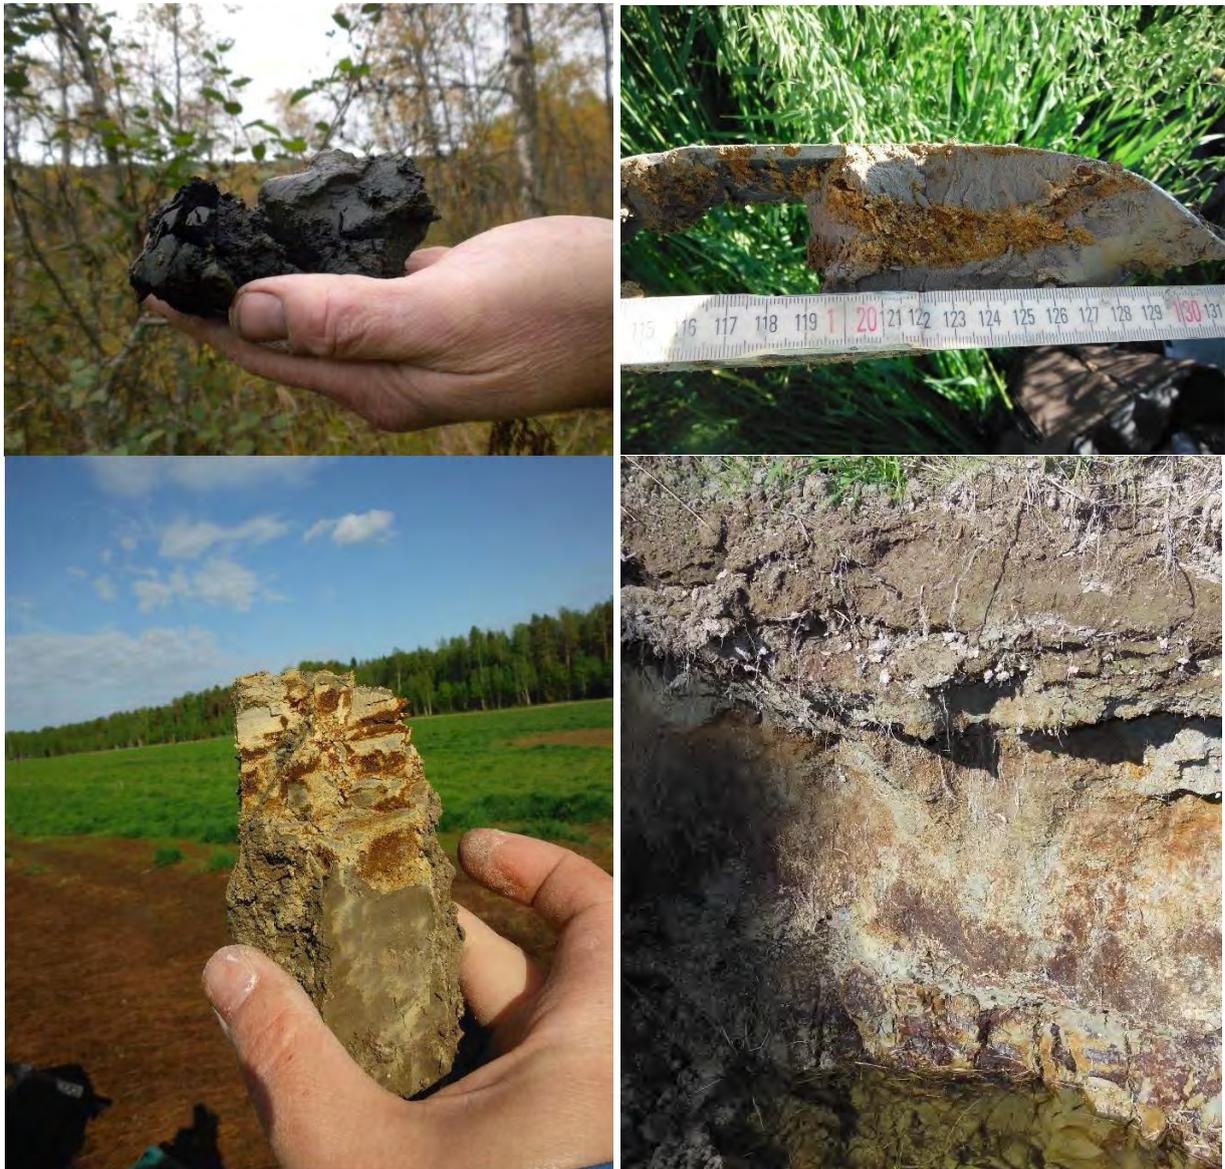
Figure 1. Top left Sulphidic, potentially acid sulphate soils with the characteristic black colour. If this soil is exposed to air for a few hours, it will assume a grey colour. Photograph: Gustav Sohlenius, SGU. Upper right and lower left Active acid sulphate soil is often characterised by rusty cracks (rust coloured deposits) and jarosite (light yellow deposits). Photograph: Nelly Aroka and Christian Öhrling, SGU. Lower right Acid sulphate soils recently exposed in a ditch in the area where the county administrative board is testing measures to limit the environmental impact of active acid sulphate soils. Photograph: Christian Öhrling, SGU.

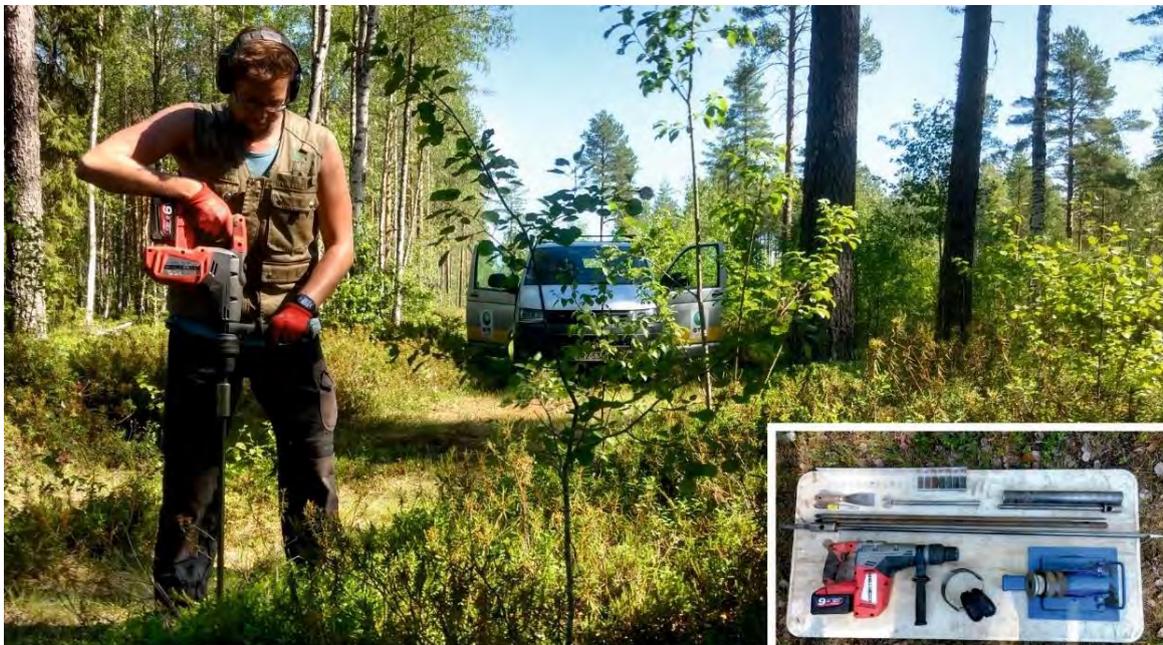
Figure 6. Sampling equipment used for rapid probing. The soil sampler is 18 mm in diameter and takes a core that is up to 1 m long. An extension probe is used to take samples at depth. A hammer drill is used to insert the sampler into the ground. Photograph: Moa Sunabacka, GTK.

At the rapid probe points in Finland, light sampling equipment (Figure 6) was used, while heavier equipment (Figure 7) was used for type profiles to allow the collection of larger samples. At the rapid probe points (about 95% of the points) soil samples were taken to a depth of 2-3 m, shallower if hard ground (till for example) or rock/stone was encountered. At each rapid probe point soil types, structure, texture, colour, oxidation depth and depth to reduced material were

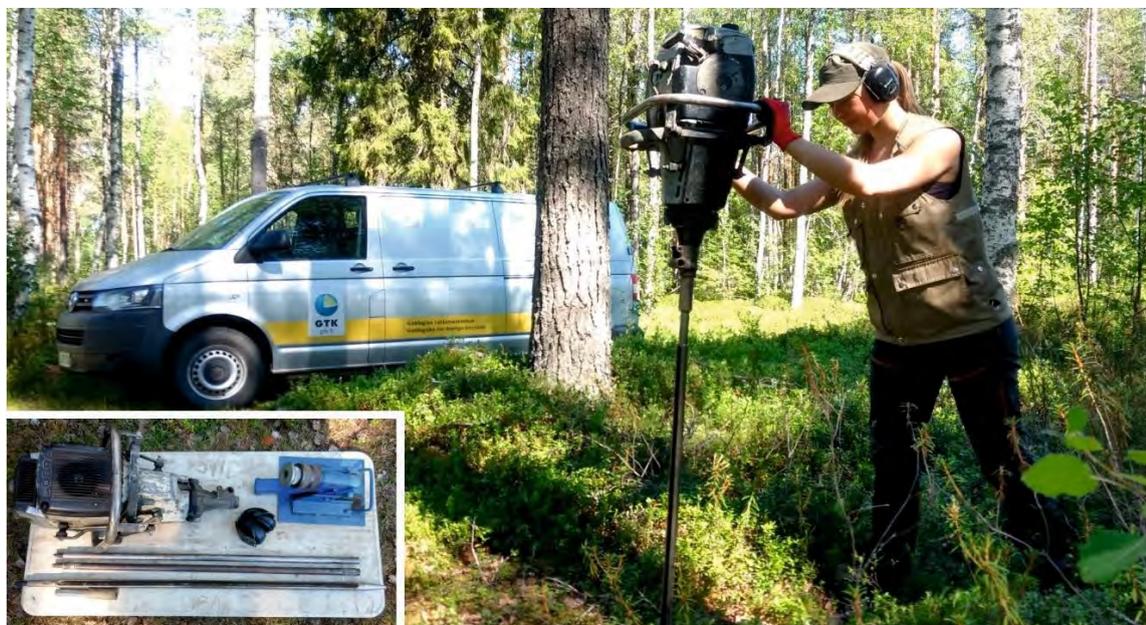
Figure 7. Sampling equipment used for type profiles. The soil sampler is 32 mm in diameter and takes a core that is up to 1 m long. An extension probe is used to take samples at depth. The sampler is hammered into the ground using an Atlas Copco Cobra breaker. Photograph: Krister Dalhem, GTK.

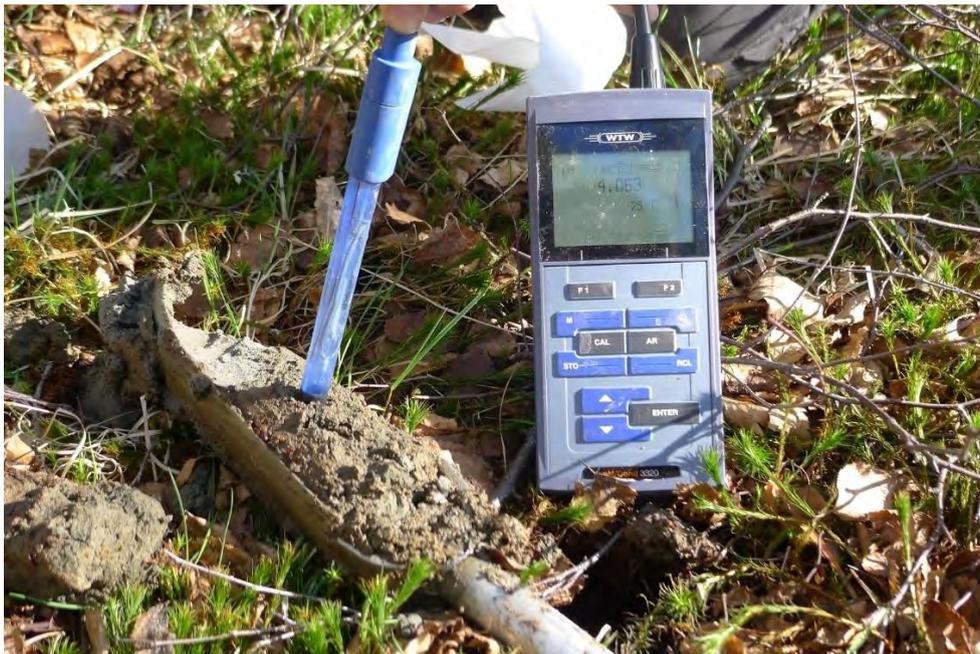
Figure 8. Measurement of pH carried out directly on the soil sample. Photograph: Gustav Sohlenius, SGU.

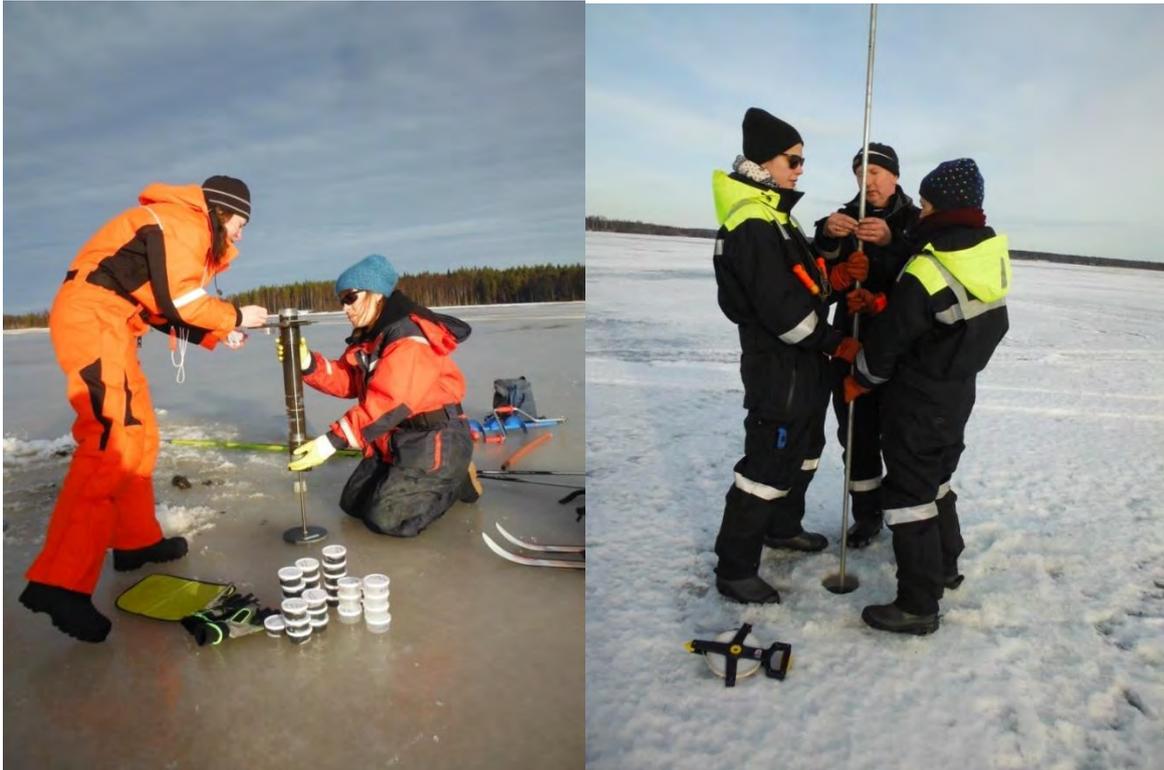
Figure 9. On the left The surface samples were taken using a Willner type surface sampler. The core was therefore sliced in-situ at two centimetre intervals. On the right The deeper sediments were sampled using a Russian chamber corer. Photograph: Gustav Sohlenius, SGU.

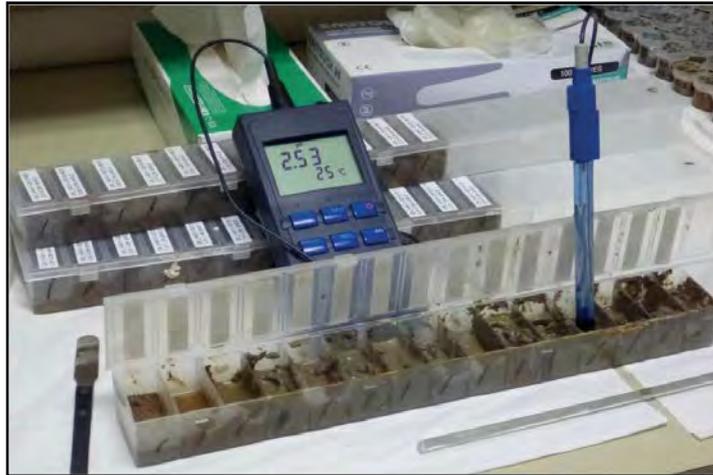
Figure 1. Incubation of soil samples in a chip tray. Photograph: Pentti Kouri, GTK.
